**August  
2012**

# **OLIVE RESIDENCE**

## **Progress Report**

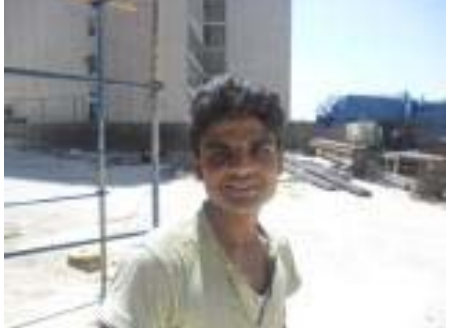
Description/Location	proposed solution	comment	PHOTOS
laborer on site not wearing "helmet,safety boot"	Usage of ppe	PPE provided but Not all subcontractors respect.

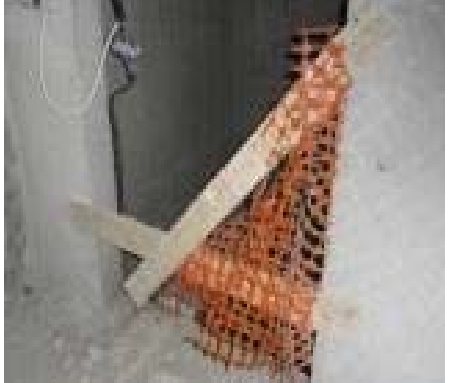
Lift on 6th floor fenced but damaged.	Lifts should be fenced properly.	No safety officer representative in site to follow up.

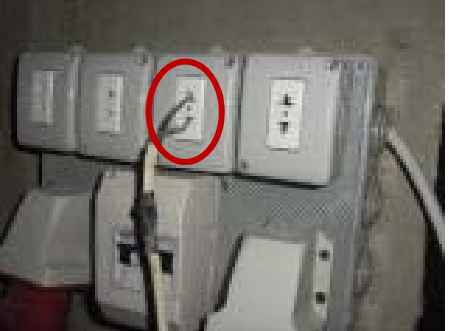
Attachment cord with bare wires '7th floor"	All cables should be covered.	No safety officer representative in site to follow up.

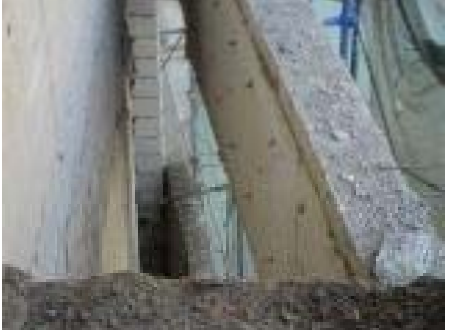
Slab end on 6th floor not covered.	Slab ends should be covered properly to avoid falling accidents.	Pending.
