November  
**2012**

# OLIVE RESIDENCE

## Progress Report

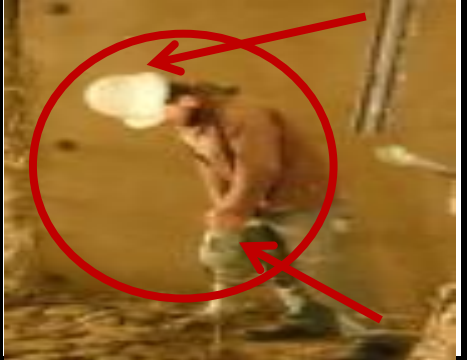
Description/Location	proposed solution	comment	PHOTOS
Laborer using ppe.	Usage of ppe	PPE used.

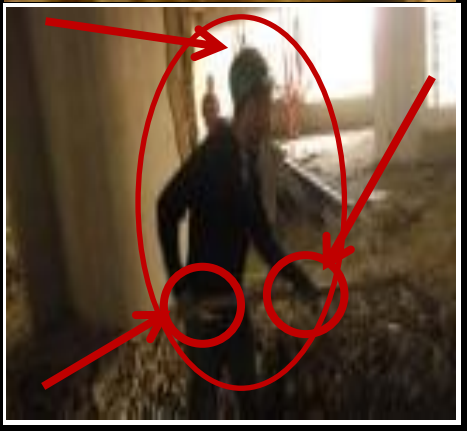
Worker on site wearing helmet,gloves while doing his job.	Usage of ppe	PPE used.
