February 2013

OLIVE RESIDENCE
Progress Report

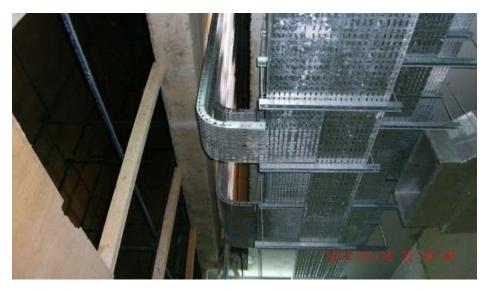
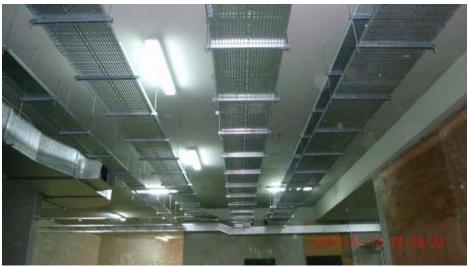
Electical: Cables tray fixed in 3 basements.
 Cables tray fixed in electrical shaft up to 12<sup>th</sup> floor.

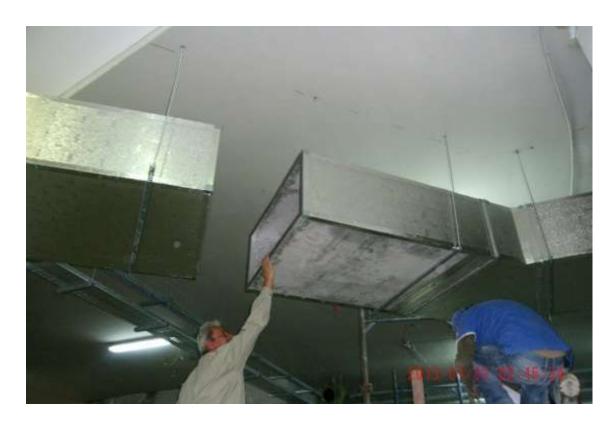
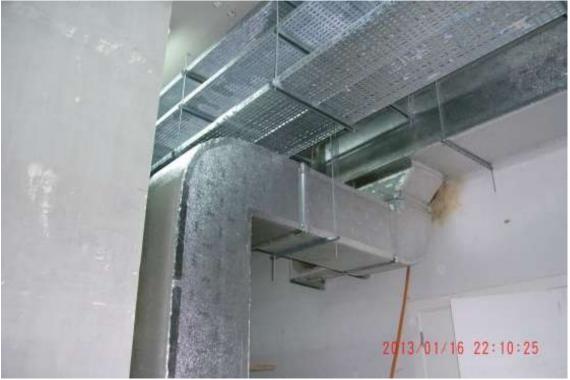
- **Mecanical**: Ducting done in 3 basements.

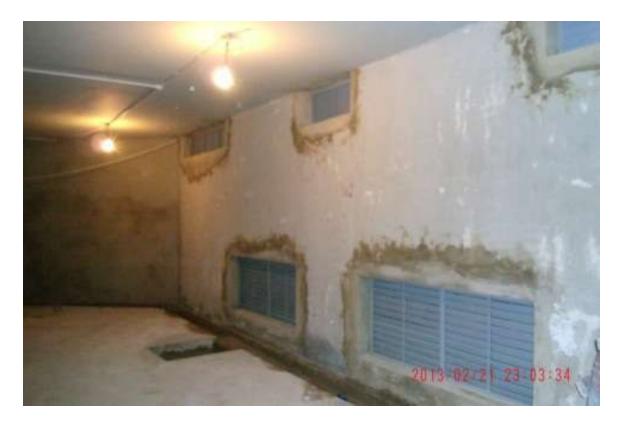
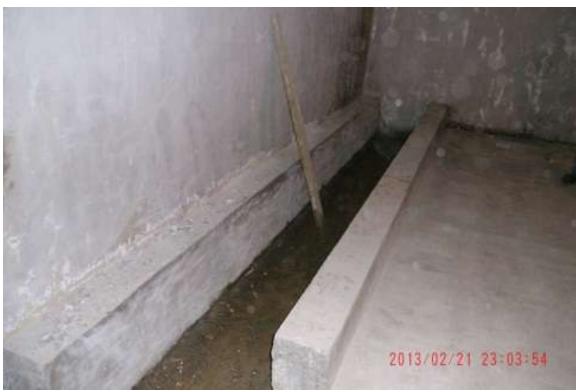
Surface preparation for transformer room: 1rst basement.

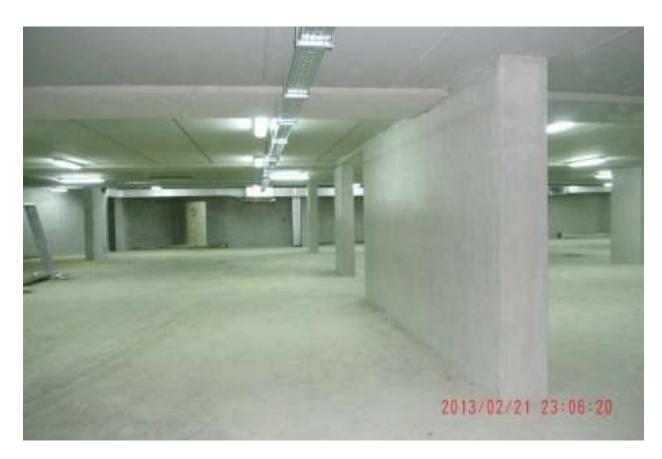
Cleaning and lighting for 3 basements floors

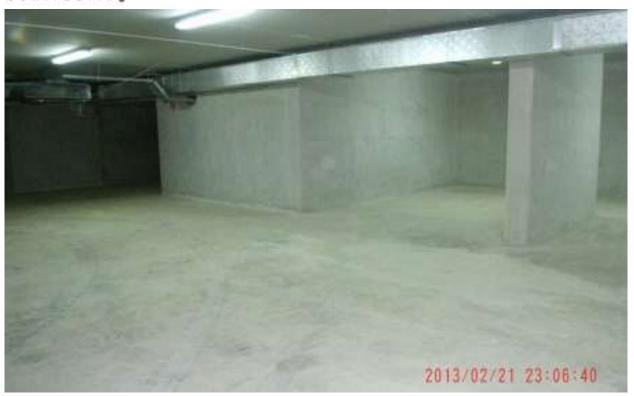
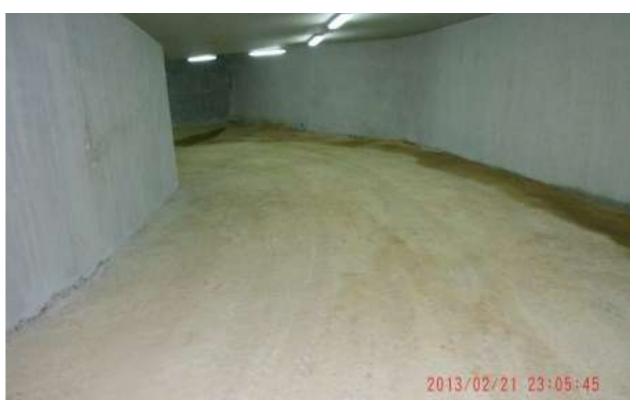
- Cleaning and lighting for 3 basements floors.

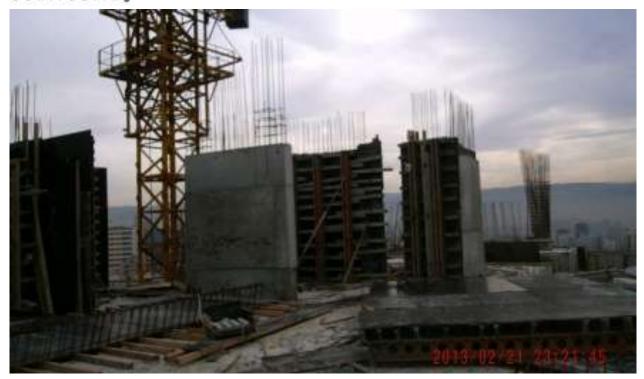
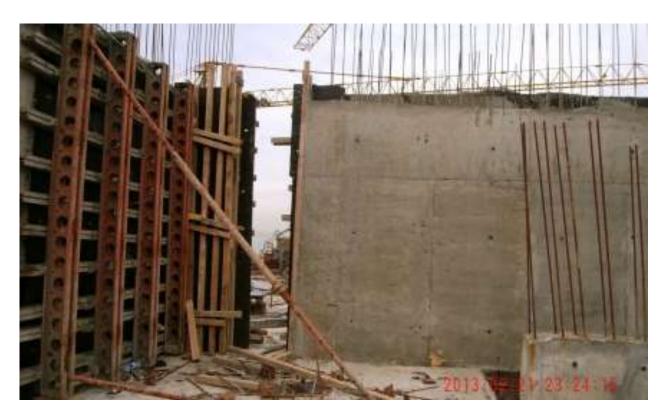
Concrete casting – Swimming pool and verticales 17<sup>th</sup> floor.

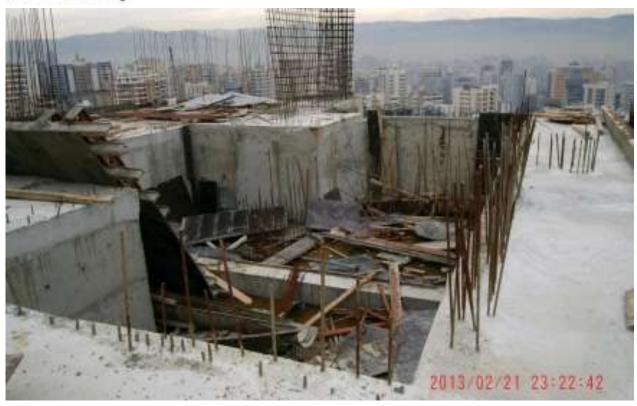
- Concrete casting – Swimming pool and verticales 17<sup>th</sup> floor.

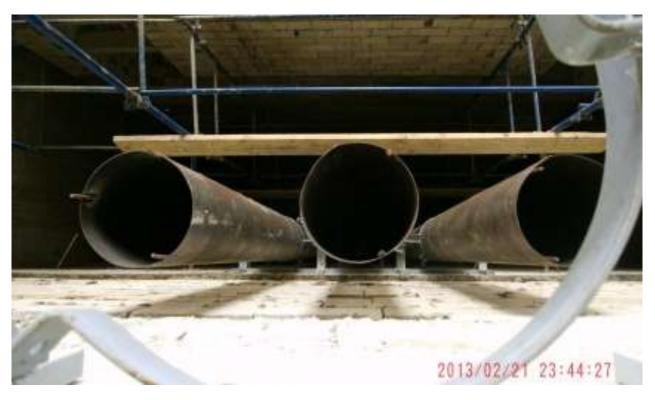
Generators exhausts up to 14<sup>th</sup> floor.

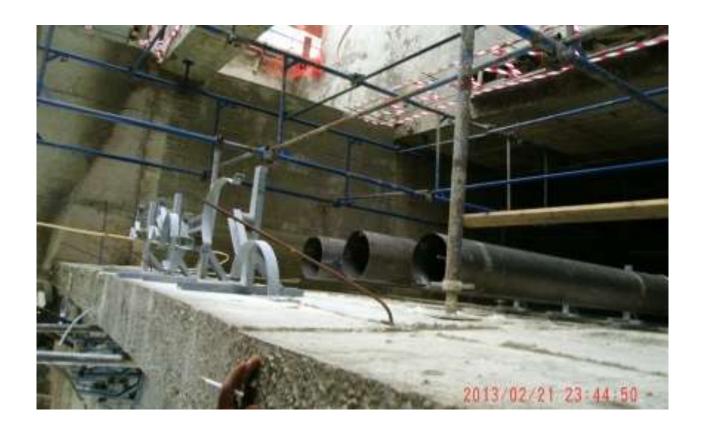
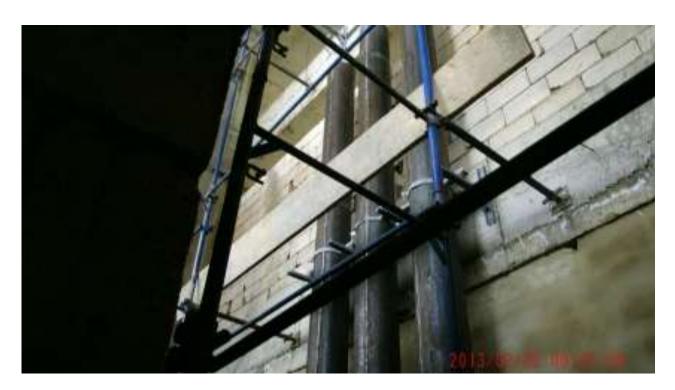
Generators exhausts up to 14<sup>th</sup> floor.

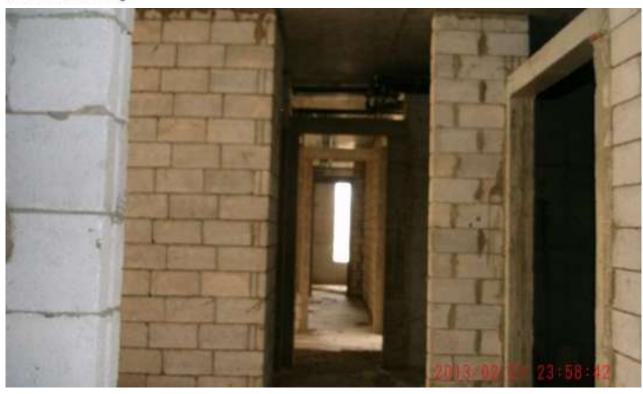
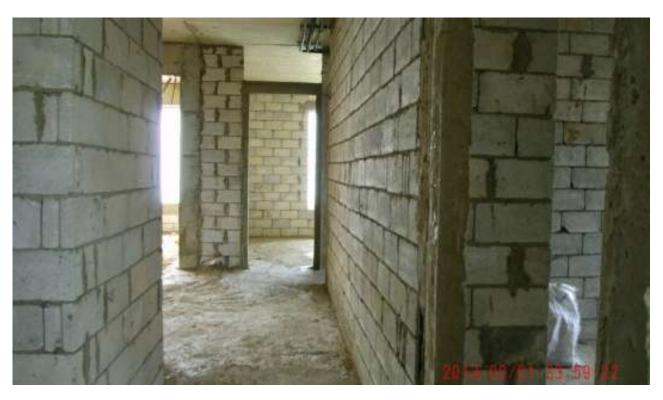
Block work done up to 12<sup>th</sup> floor.

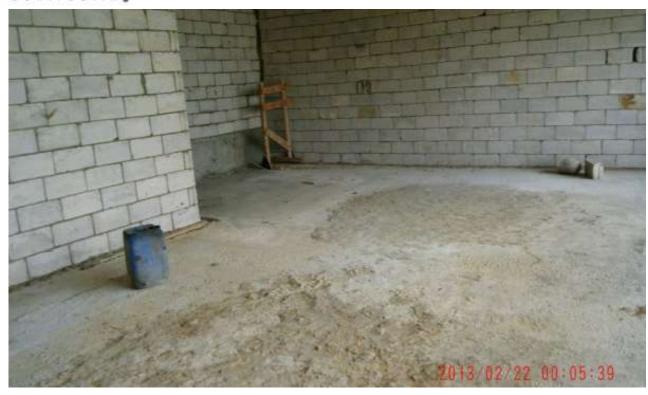
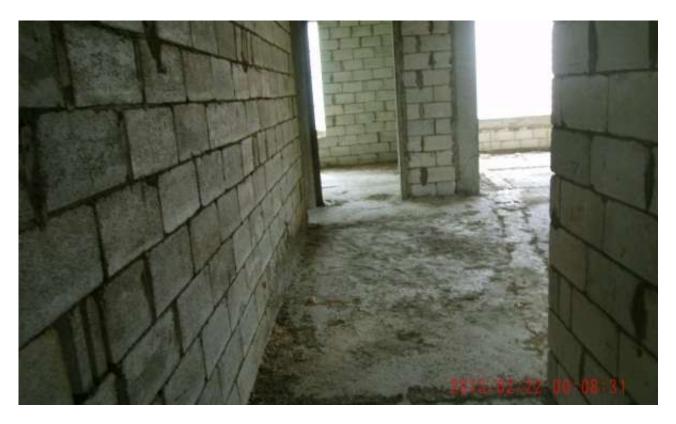
All floors cleaned.

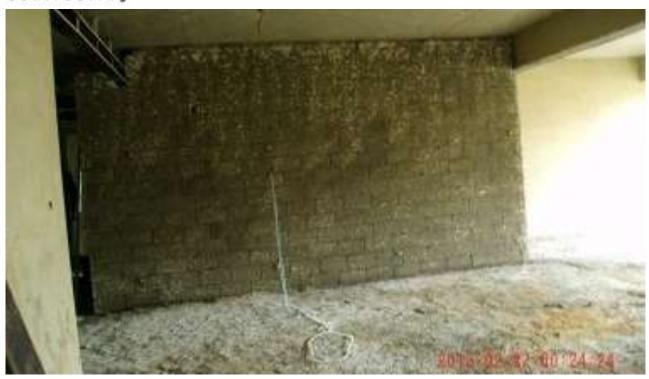
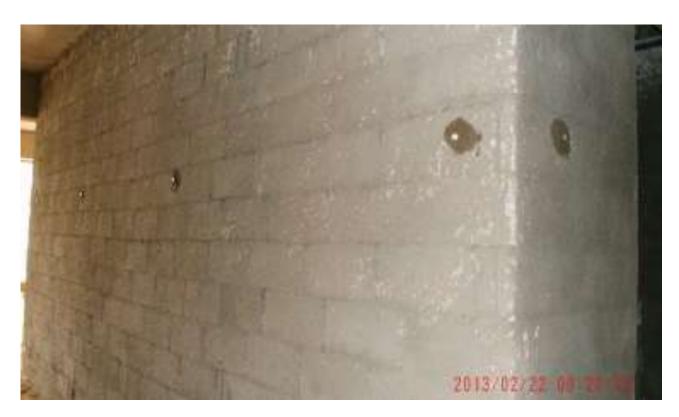
Rush coat and plastering.

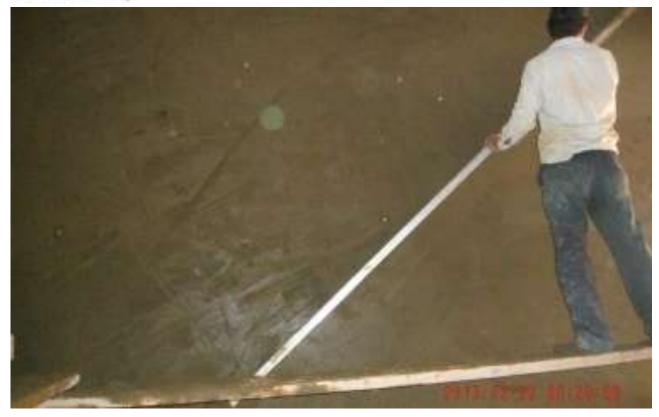
Rush coat and plastering.

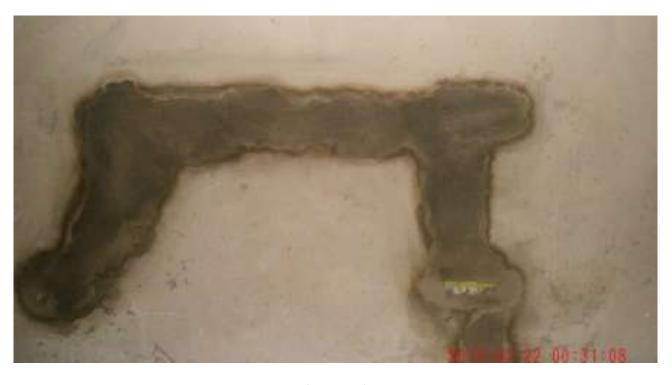
New electrical revision.

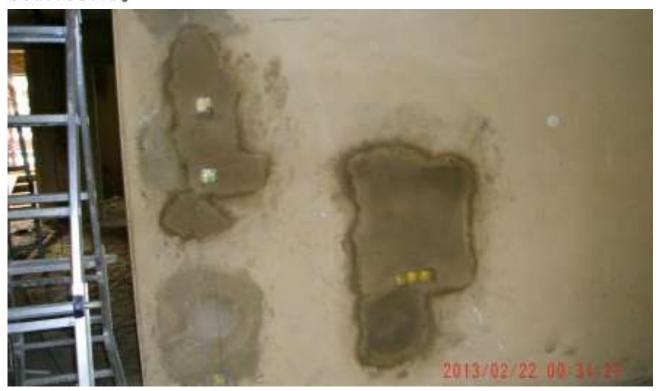
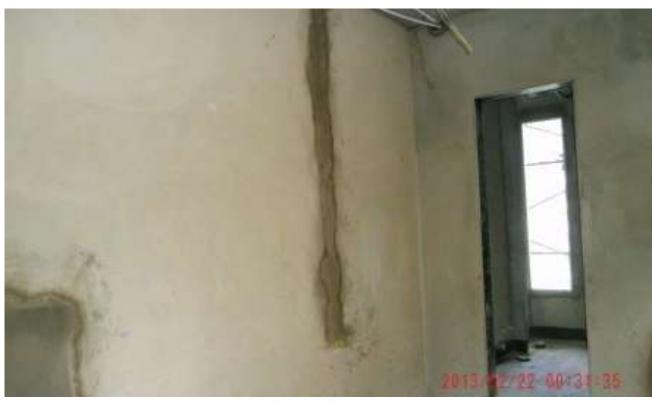
New electrical revision.

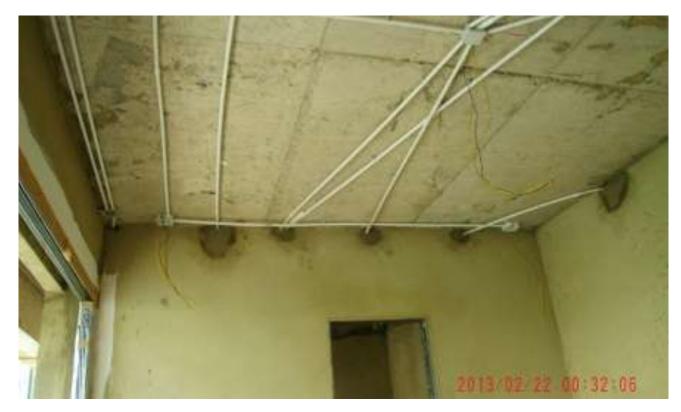
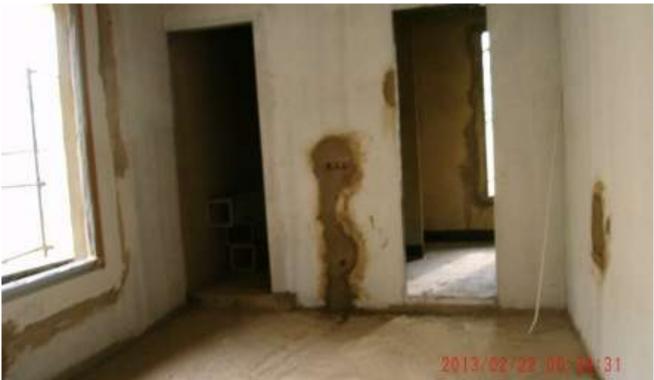
- New electrical revision.

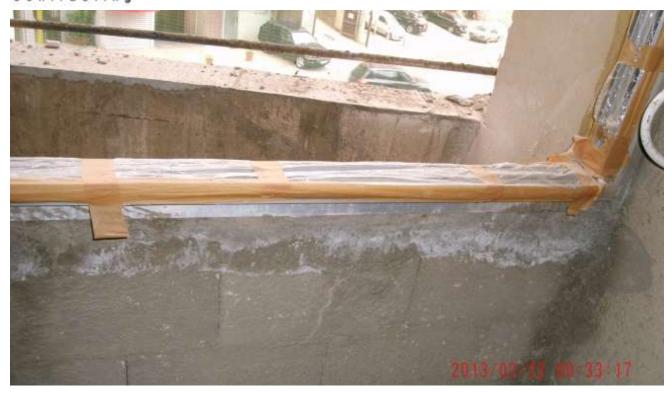
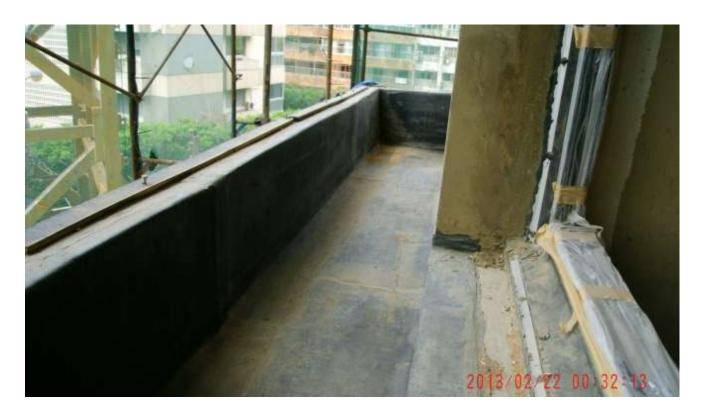
- Aluminium frame and subframe protection.
