May 2013

OLIVE RESIDENCE
Progress Report

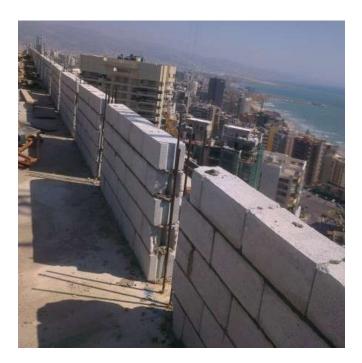
- Blockwork in 16th and attic floors.

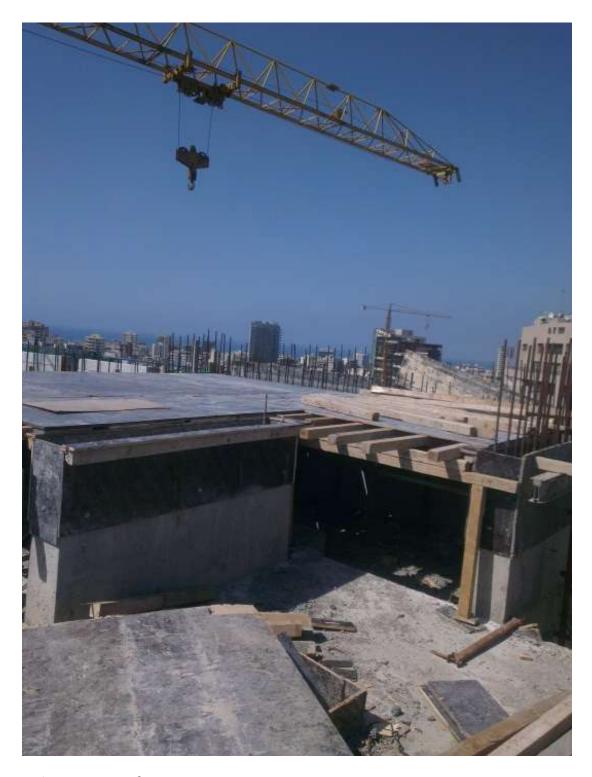
- Blockwork at roof level.
