July
2012

PATRIARCAT 482

Progress Report

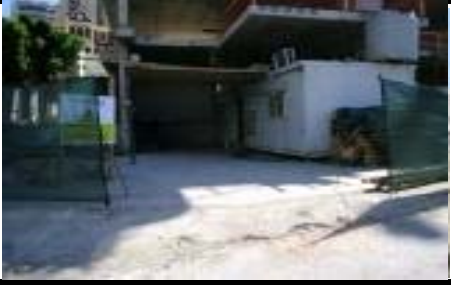
Project Name : Batrakieh			Date :25 /07/2012
Project Manager : Joseph Antonios			Reference : KR/0003/B
Health & Safety Inspector : Kassem Raya			
Description/Location	proposed solution	comment	PHOTOS
Safe Site entrance	Site entrance must be safe	Done

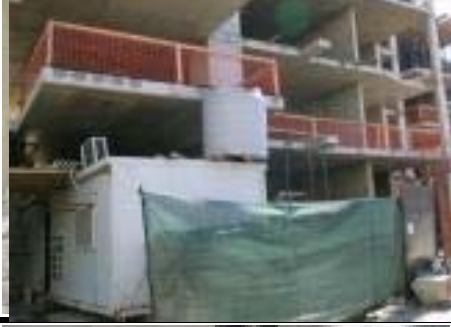
Balconies on site not fenced "all floors"	Balconies should be fenced to avoid falling accidents	All balconies on site are fenced

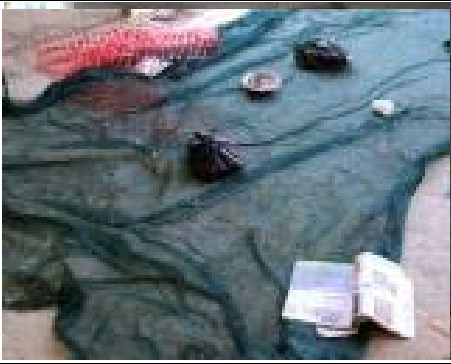
Edge on 2nd and 3rd floor fenced.	Edges should be fenced to avoid falling accidents.	Done	 
wastes and food rests on the floor	Floor must be clean	Action taken on the spot.

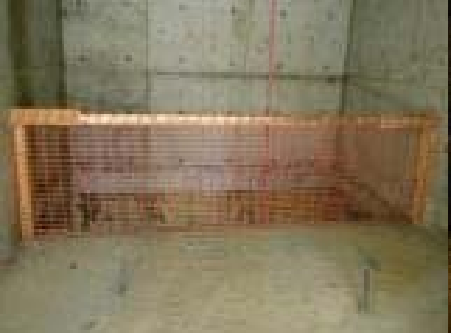
Openings in the 1st,2nd and 3rd floor closed	All openings must be closed to prevent falling accidents	Done	 
Edge on 2nd and 3rd floor from the back of the site not fenced.	Edges should be fenced to avoid falling accidents.	Edges all around the site are fenced	 
Shafts fenced by wood and orange construction safety net on 1st ,2nd and 3rd floor	All shafts should be fenced	Corrected.

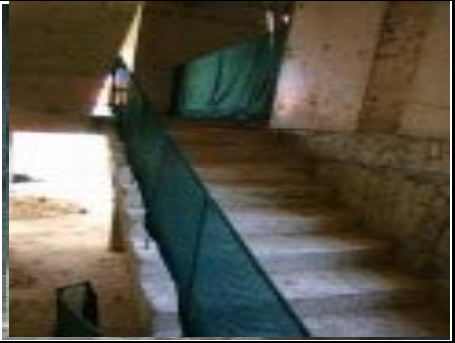
Project Name : Batrakieh			Date :25 /07/2012
Project Manager : Joseph Antonios			Reference : KR/0003/B
Health & Safety Inspector : Kassem Raya			
Description/Location	proposed solution	comment	PHOTOS
Stairs fenced with handrail	Stairs should be fenced to avoid accidents.	All the stairs on site fenced.

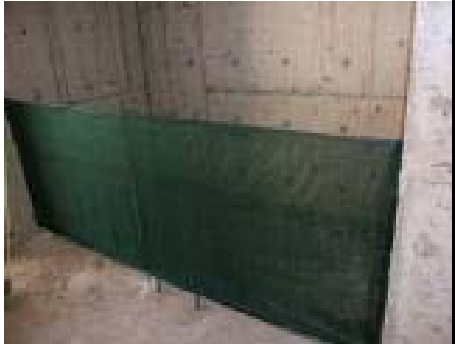
Shafts on all floors fenced	Shafts should be fenced.	Done

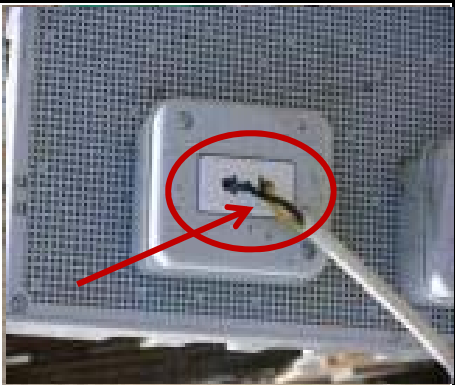
Electrical cord not covered "2nd floor"	Electrical equipments should be used properly and cables should be covered.	Corrected.

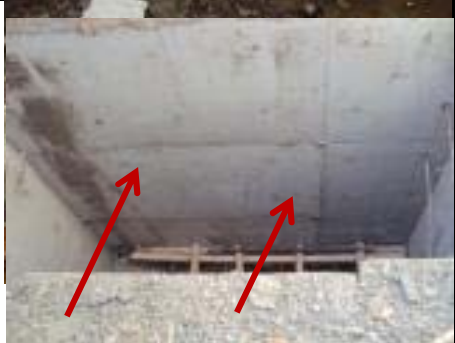
Shaft on 2nd floor not fenced.	Shafts on site should be fenced to avoid falling accidents.	Corrected.

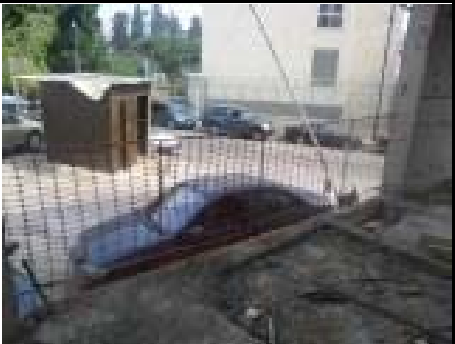
Slab end on the 1st floor fenced.	All slab ends on the site should be fenced.	Corrected.

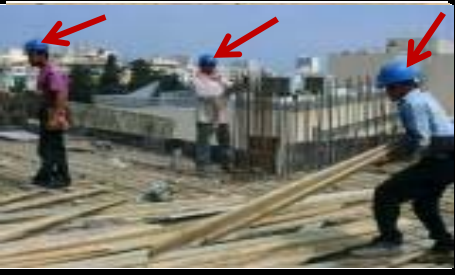
Laborers on site wearing helmet and safety boots.	Usage of PPE.	PPE used.

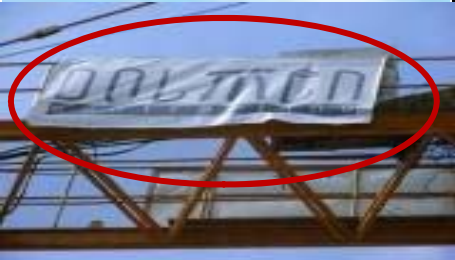
Dolmen name board is fixed on a high point on the tower crane	Dolmen name should be existing on high points of the project	Done
