August
2012

PATRIARCAT 482

Progress Report

DOLTAEN
contracting

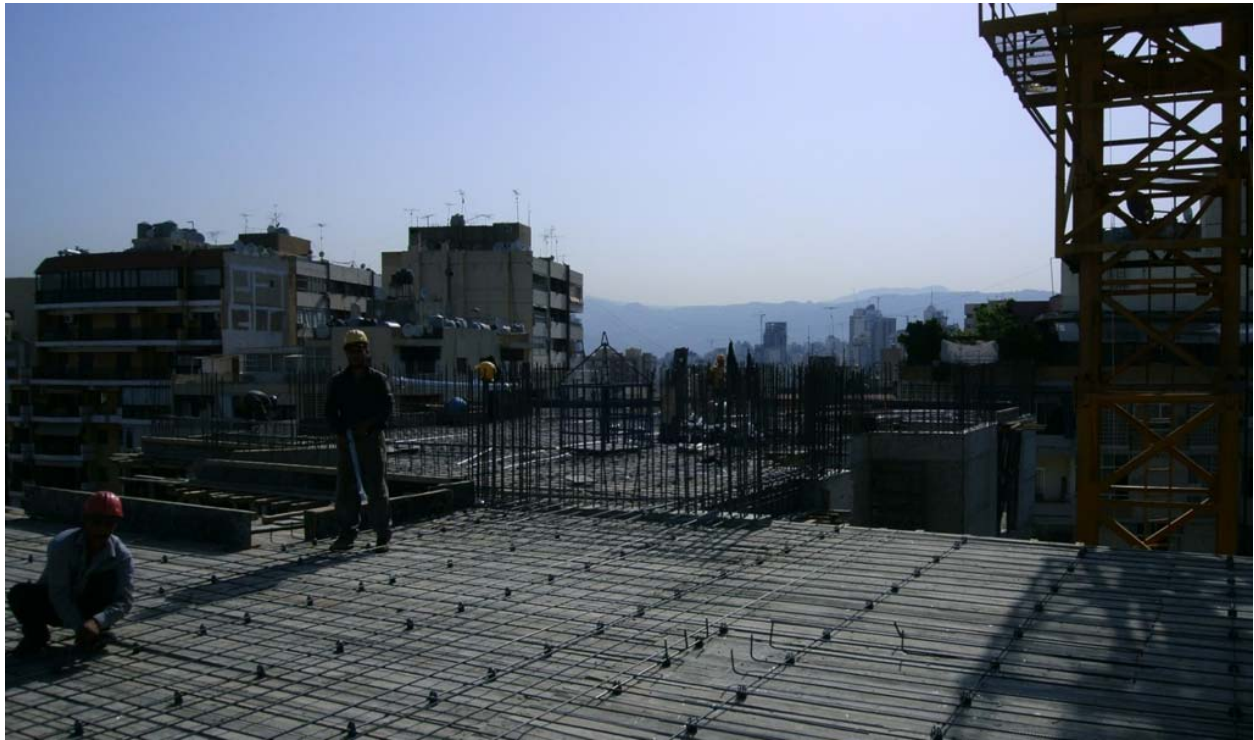
Figure 2: Preparation for pouring 6th floor slab

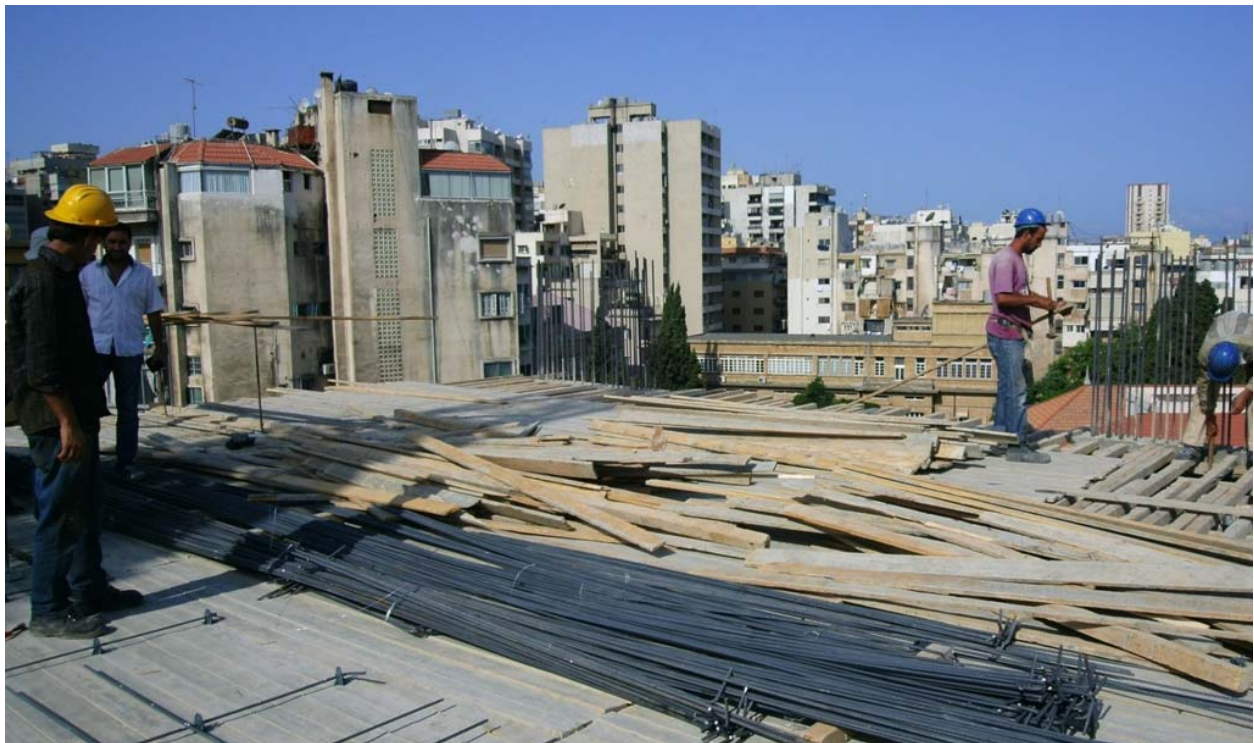
Figure 3: Preparation for pouring 6th floor slab

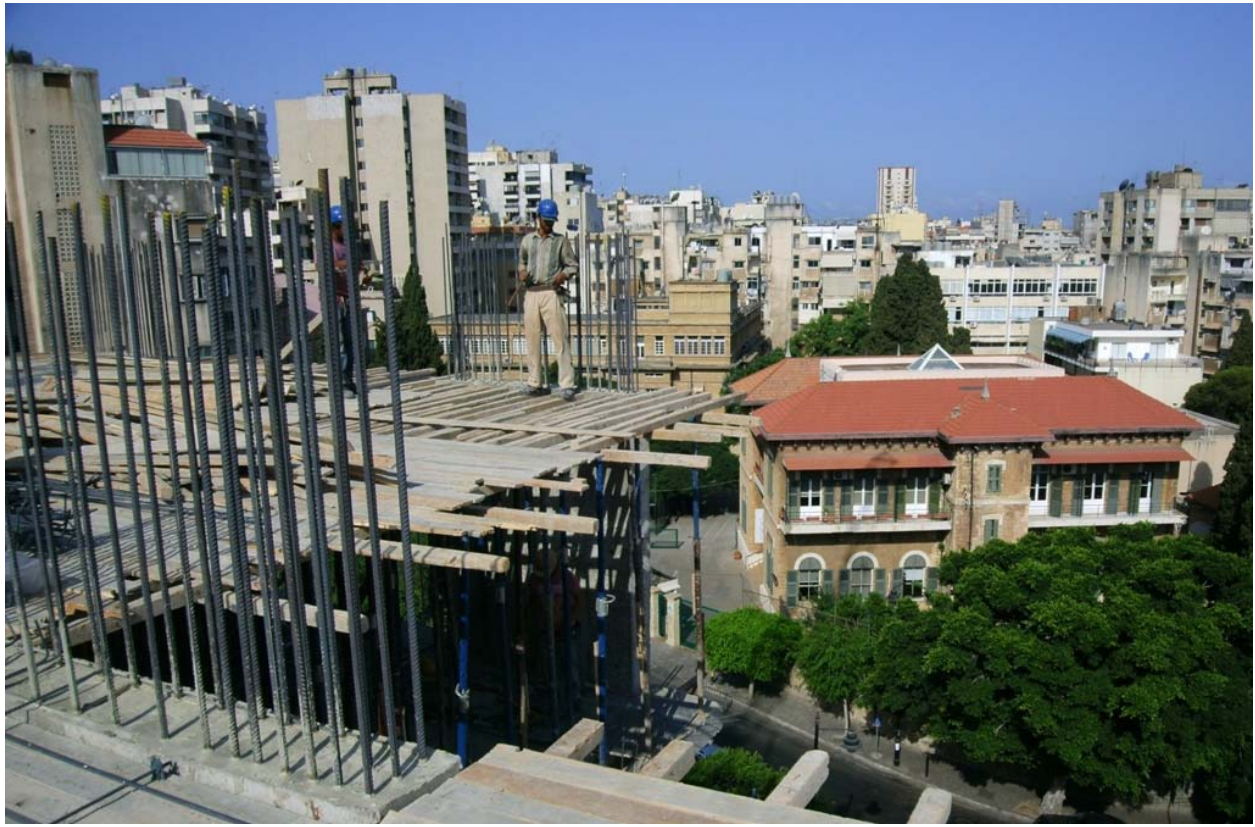
Figure 4: Preparation for pouring 6th floor slab

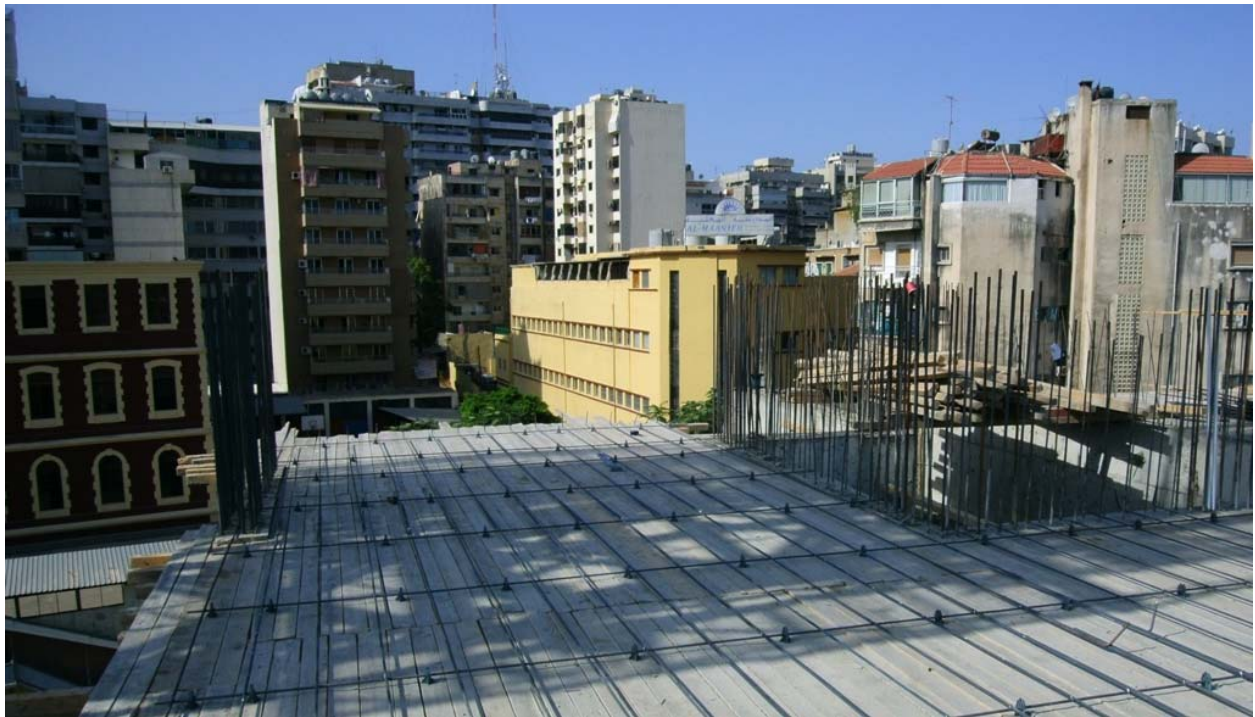
Figure 5: Preparation for pouring 6th floor slab

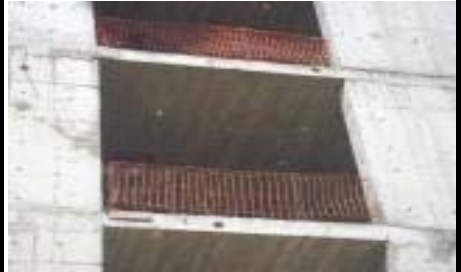
Description/Location	proposed solution	comment	PHOTOS
Edges from all sides fenced	Edges should be fenced to avoid falling accidents.	Done

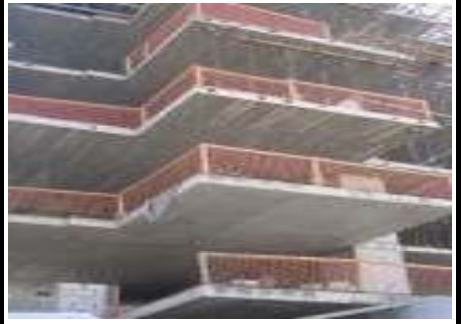
Balconies on all floors are fenced	Balconies should be fenced to avoid falling accidents	All balconies on site are fenced

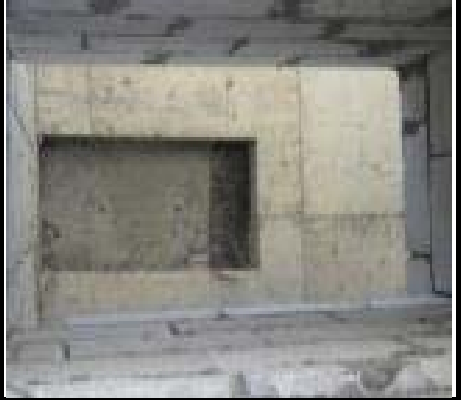
Openings in the 4th and 5th floor closed	All openings must be closed to prevent falling accidents	Done

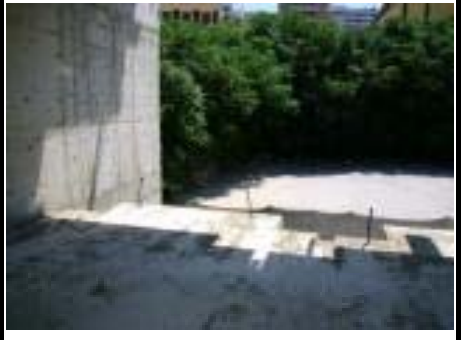
Edge on 4nd and 5rd floor from the back of the site not fenced.	Edges should be fenced to avoid falling accidents.	Edges all around the site are fenced

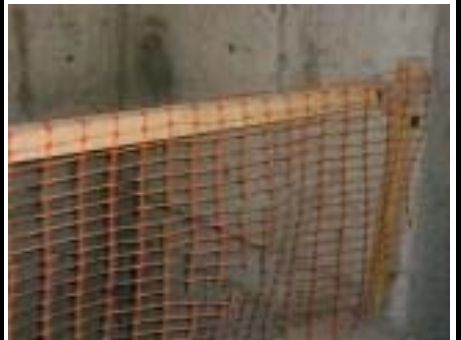
Shafts fenced by wood and orange construction safety net on 4th and 5th floor	All shafts should be fenced	Corrected.
