PATRIARCAT 482

Progress Report

September
2012

Health & Safety Report

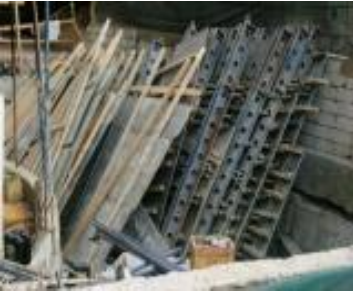
Project Name : Batrakeh		Date :25 /09/2012	
Project Manager : Jossef Antonios		Reference : KR/0006/B	
Health & Safety Inspector : Kassem Raya			
Description/Location	proposed solution	comment	PHOTOS
Entrance of Basements closed by woods and iron	Entrance must clean and safe	Pending, contractor had been told to remove them as soon as possible

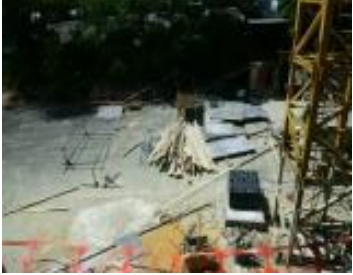
Parking of Batrakeh full of woods and contractors tools	Site should be tidy.	Parking cleaned completely

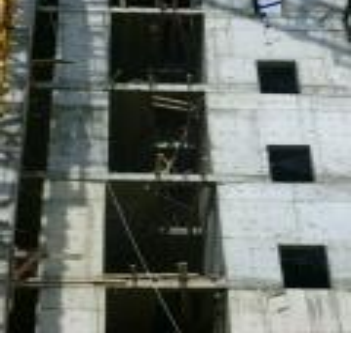
Edge from back of site are not fenced.	Edges should be fenced to avoid falling accidents.	action done

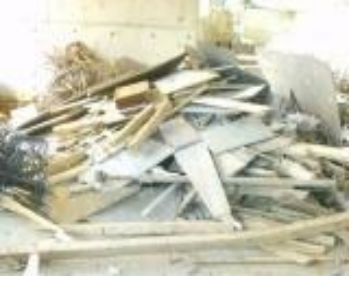
Wastes and rests on the floor	Floor should be clean	Action taken on the spot.

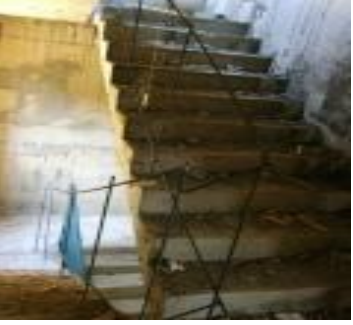
Stairs fenced with handrail	Stairs should be fenced to avoid accidents.	All the stairs on site fenced.

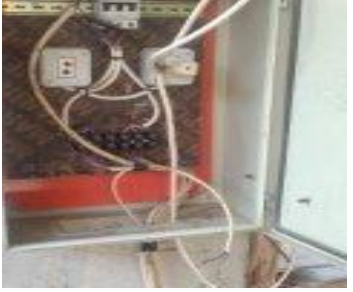
Electrical cord not covered	Electrical equipments should be used properly and cables should be covered.	Corrected.

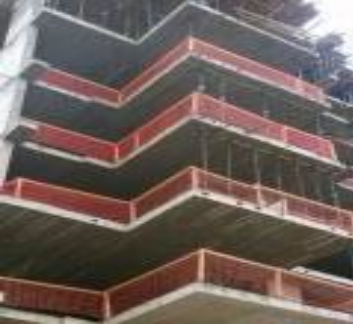
Balconies on all floors are fenced	Balconies on site should be fenced to avoid falling accidents.	Done

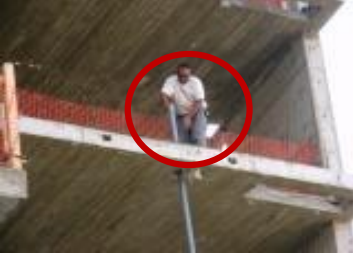
Laborer not wearing helmet and working at high level unsafe	Usage of PPE.	PPE used.
