November
2012

PATRIARCAT 482

Progress Report

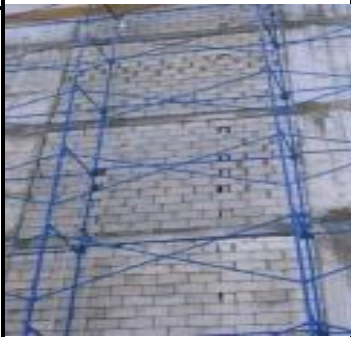
Project Name : Batrakeh		Date :25 /11/2012	
Project Manager : Jossef Antonios		Reference : KR/0008/B	
Health & Safety Inspector : Kassem Raya			
Description/Location	proposed solution	comment	PHOTOS
Scaffold began to surround the site	Scaffolds must be found to avoid falling of things and make damages	we are facing some problems during this action but most of them are solved

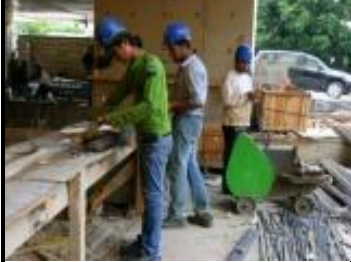
Laborers wearing helmets and safety boots	Usage of PPE	Done

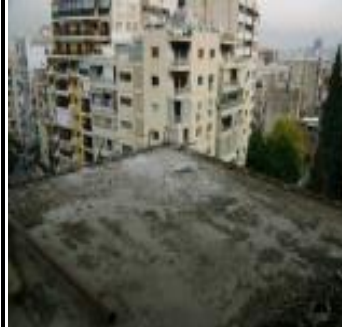
Balconies at high levels are not fenced	Balconies should be fenced to avoid falling accidents.	action done

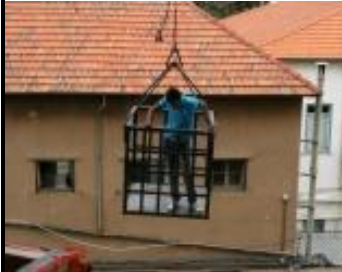
Labore using the crane to go up to the high stairs in unsafe action	lifts must be found to avoid like these cases	Pending ,All persons had been told not to use the crane in all cases

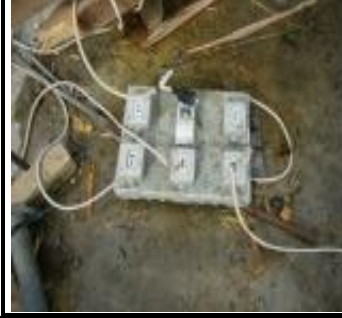
Electrical cables are not covered and put in bad way	electrical equipments should be used properly and electrical cables must be covered	Corrected

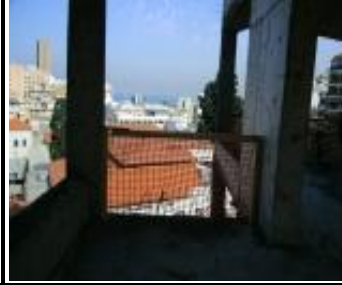
Edges at high levels are fenced	Edges should be fenced to avoid falling accicednts	Done

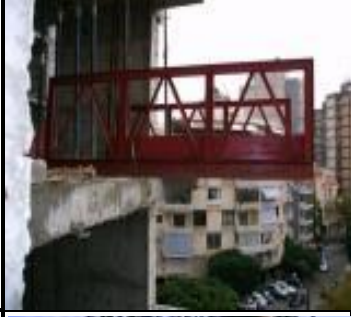
Platforms are put to make work easier	platform shoukld be used.	Done
