January
2013

PATRIARCAT 482

Progress Report

Health & Safety Report

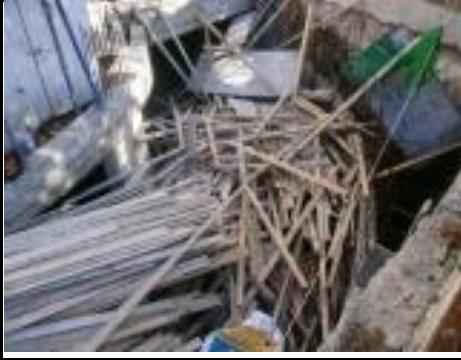
Basements entrance closed by woods	Site entrance should be clean and open	<u>pending ,because there is no enough area to remove and contractor had been told to remove ASAP</u>

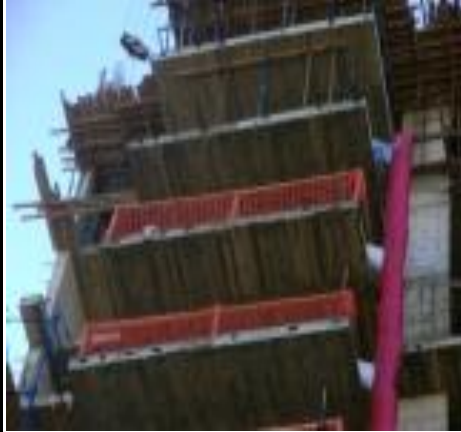
Balconies at high levels are fenced	Balconies should be fenced to avoid falling accidents.	action done

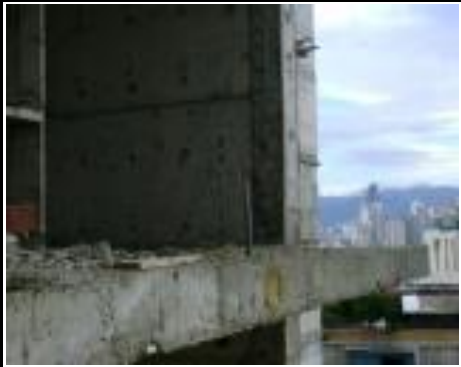
Edges at high levels are not fenced	Edges should be fenced to avoid falling accidents	Done

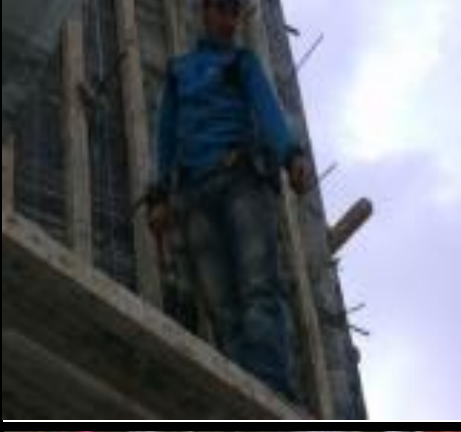
Labour working at high level not safe	Labourers must wear safety belts	Labourer was warned and action taken

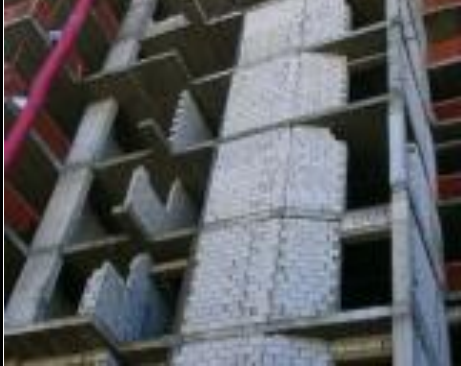
Edges at high levels are not fenced	Edges should be fenced to avoid falling accidents	Done

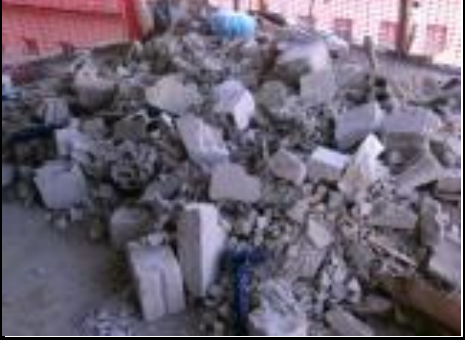
Large amounts of debris	Floors should be clean	Action taken

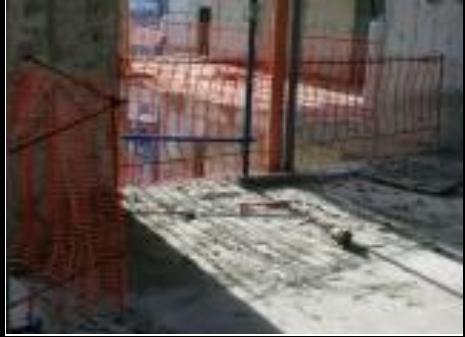
Edges from back of the site are fenced	Edges should be fenced	Done

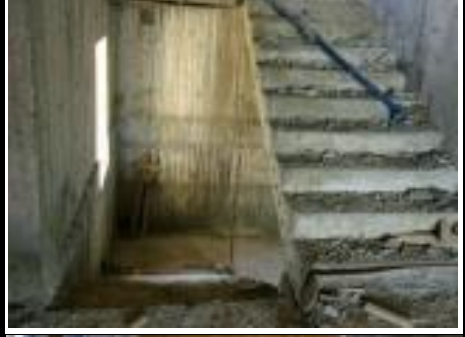
Stairs not fenced and not clean	Stairs must be fenced and clean	Done

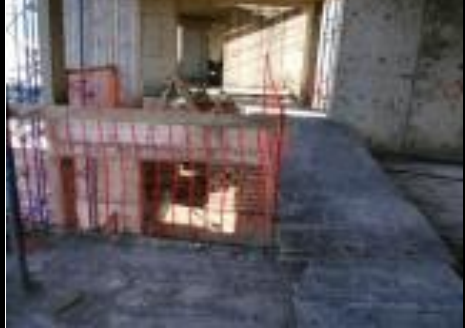
Balconies fenced and safe path between the two blocks	Balconies must be fenced	Done
