February
2013

PATRIARCAT 482

Progress Report

DOLTAEN
contracting

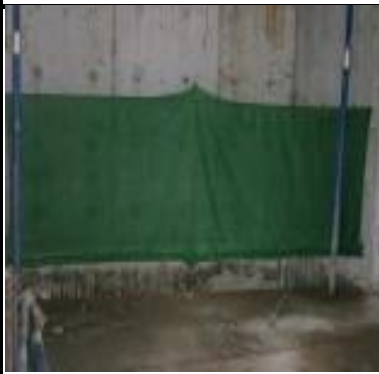
Project Name : Batrakeh		Date :20 /02/2013	
Project Manager : Abir Kaafarani		Reference : KR/0011/B	
Health & Safety Inspector : Kassem Raya			
Description/Location	proposed solution	comment	PHOTOS
Lift openings at high levels are fenced	Opening should be fenced to avoid falling accidents	Done

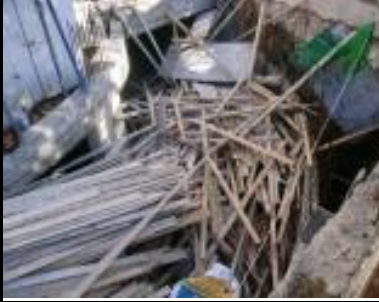
Basements entrance closed by woods	Site entrance should be clean and open	<u>pending ,because there is no enough area to remove and contractor had been told to remove ASAP</u>

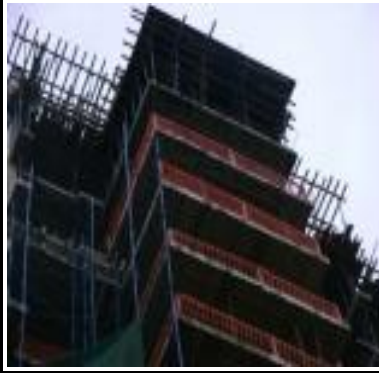
Balconies at high levels are fenced	Balconies should be fenced to avoid falling accidents.	action done

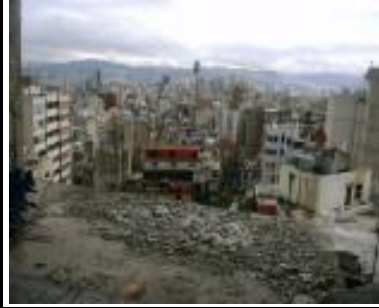
Edges at high levels are not fenced	Edges should be fenced to avoid falling accidents	Done

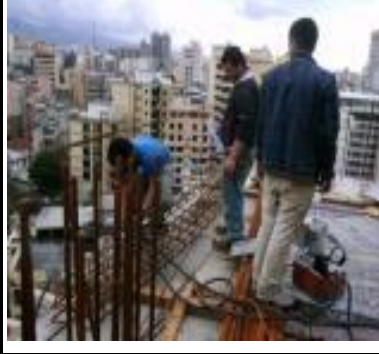
Labour working at high level not safe	Labourers must wear safety belts and helmets	Labourer was warned and action taken

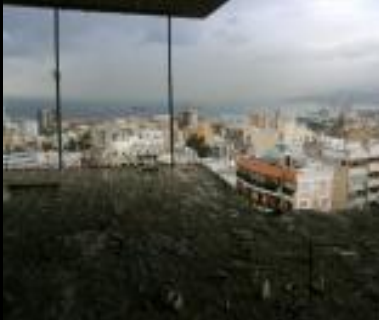
Edges at high levels are not fenced	Edges should be fenced to avoid falling accidents	Done

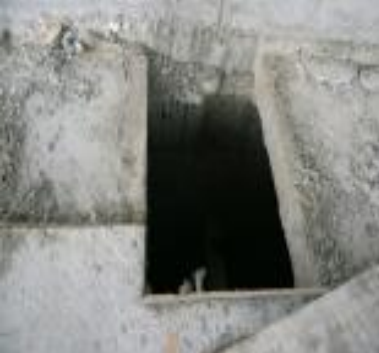
Opening are not covered and fenced	All openings should be covered and fenced	Done

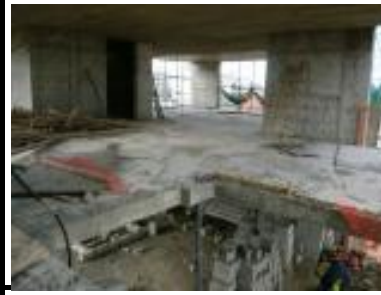
Project Name : Batrakeh		Date :20 /02/2013	
Project Manager : Abir Kaafarani		Reference : KR/0011/B	
Health & Safety Inspector : Kassem Raya			
Description/Location	proposed solution	comment	PHOTOS
Large aamounts of debris	Floors should be clean	Action taken	 
Edges are not fenced	Edges should be fenced	Done

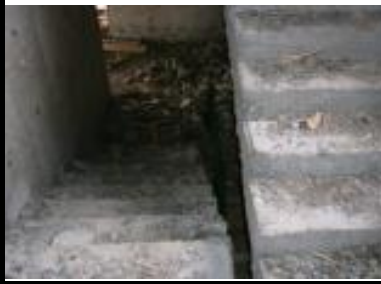
Stairs not fenced and not clean	Stairs must be fenced and clean	Done

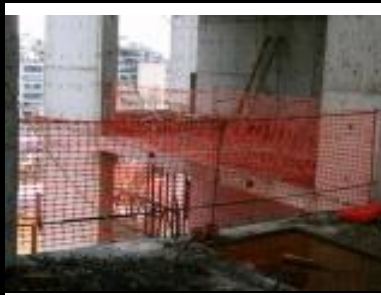
Edges from back of the site are fenced	Edges must be fenced	Done

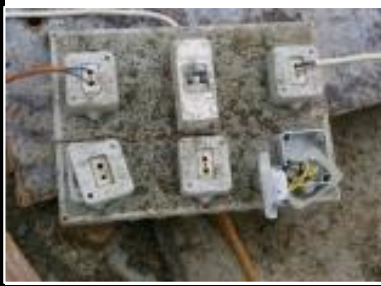
Electrical equipments are not used	Electrical equipments must be used	Corrected

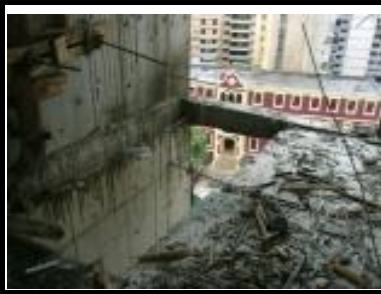
Openings are not covered and not fenced	Openings must be covered and fenced to avoid falling accidents	Action taken

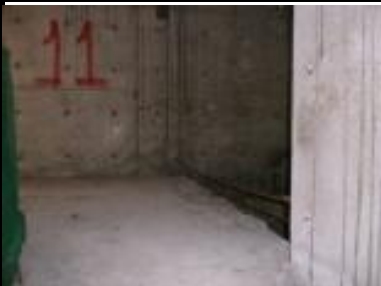
Lift Openings at 11th floor are not fenced	Openings must be fenced to avoid falling accidents	Action taken
