September
2012

SPOT -C-

Progress Report

Project Title:	Choueifat Mall	CM
Location:	Choueifat, Lebanon	
Developer:	B.A. Choueifat	BA
Main Contractor:	Dolmen contracting	DC
Shoring subcontractor-1	DST	DST
Shoring subcontractor-2	MGM	MGM
Consultant	DNA	DNA
Technical Control	Socotec	STC
Building Materials Consultant	3PE-3rd Party Engineering	3PE

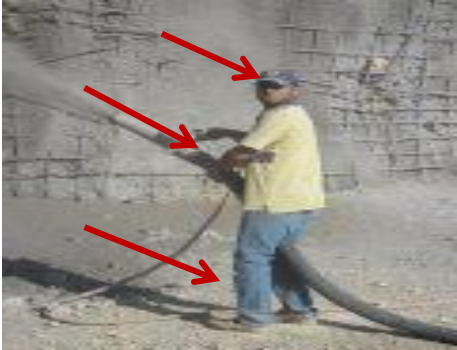
Description/Location	proposed solution	comment	PHOTOS
<p>Laborer on site not wearing helmet,gloves and safety boot.</p>	<p>Usage of PPE.</p>	<p>Pending due to DST not provided PPE for laborers yet.</p>

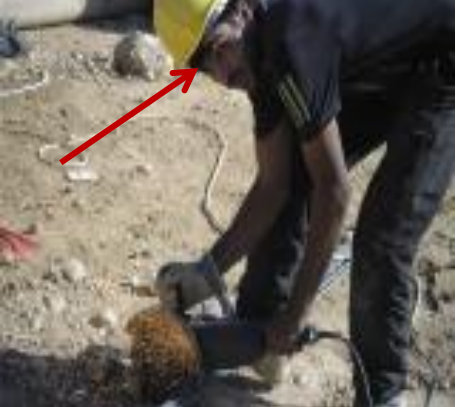
<p>Not wearing the goggles.</p>	<p>Usage of goggles.</p>	<p>Goggles used.</p>

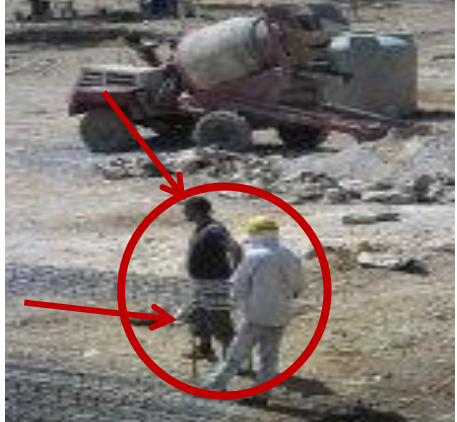
<p>Laborer on site without helmet and wearing flip-flops .</p>	<p>Usage of ppe.</p>	<p>PPE used.</p>
