September
2012

YARZE 3244

Progress Report

DOLMEN
contracting

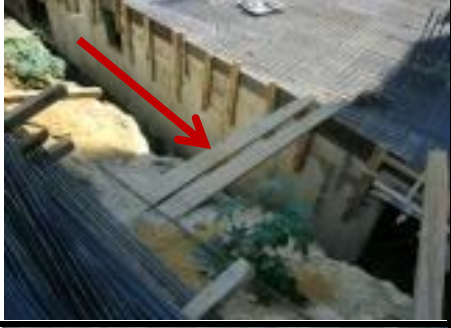
Project Name : Yarzi		Date :25 /09/2012	
Project Manager : Joseph Antonios		Reference : KR/0001/Y	
Health & Safety Inspector : Kassem Raya			
Description/Location	proposed solution	comment	PHOTOS
Unsafe entrance and passageway.	Site entrance should be safe.	Done.

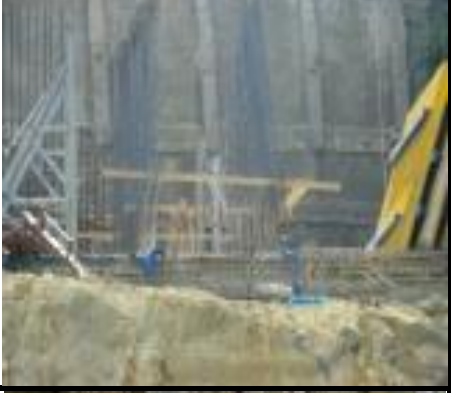
High edge not fenced.	Edges should be fenced to avoid falling accidents.	Pending,order done to get fences in order to solve this.

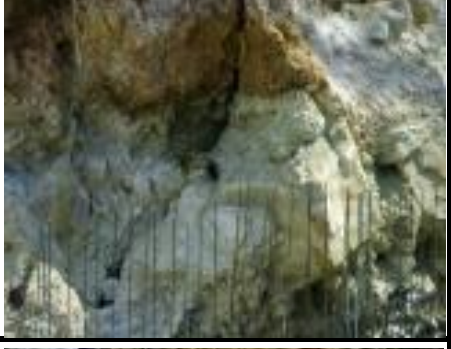
Wall is about to fall.	Site should be safe workplace.	pending,waiting to finish the first slab in order to take action

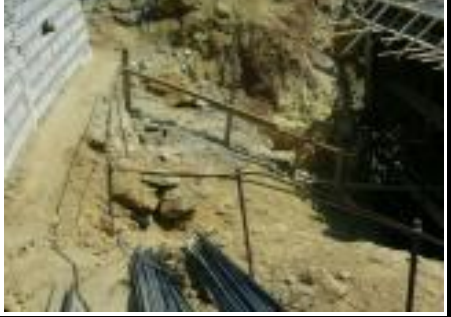
Unsafe path and cause falling accidents.	Path and entrance must be safe to prevent falling accidents	Pending,trying to insure safe path
