October  
**2012**

# YARZE 3244

## Progress Report

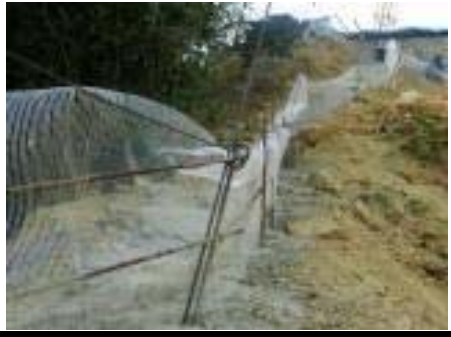
Description/Location	proposed solution	comment	PHOTOS
Way relating the two Blocks	Ways must be safe	Concrete had been put to insure safe path and fence done

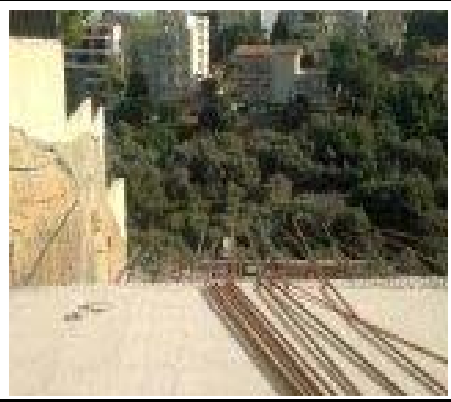
High edge not fenced.	Edges should be fenced to avoid falling accidents.	Done

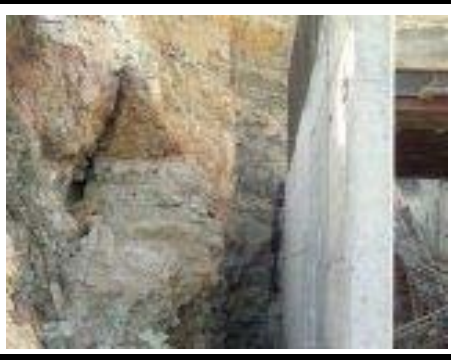
Wall is about to fall	Site should be safe work place.	Concrete Wall had been done and so it become safe

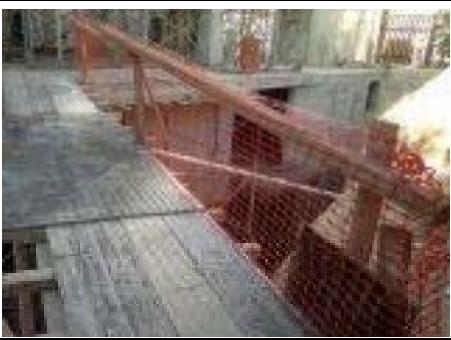
Safe path and entrance to the site	Path and entrance must be safe to prevent falling accidents	Done

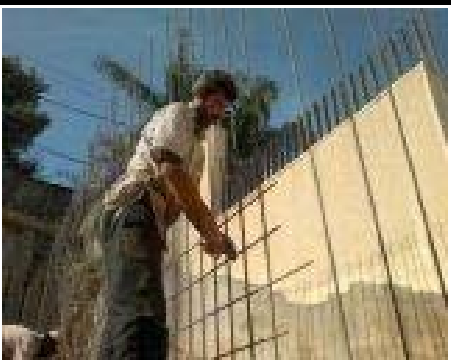
Laborer not wearing helmet and safety belt.	Usage of PPE.	PPE used.
