November  
**2012**

# YARZE 3244

## Progress Report

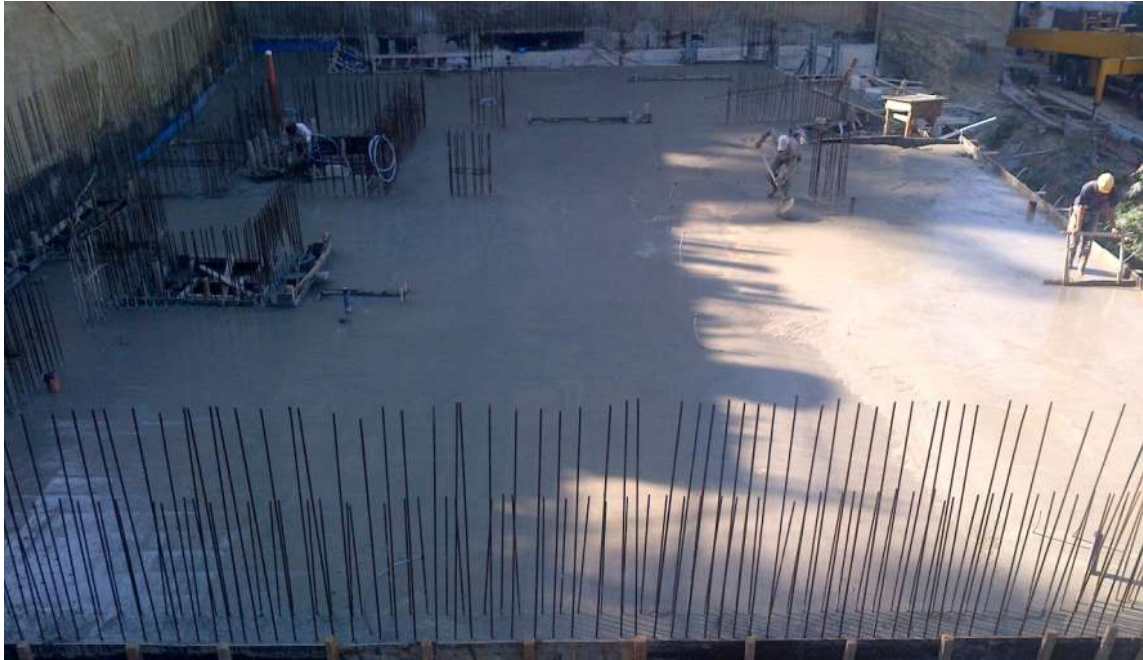
**Figure 2-Level 1 slab**

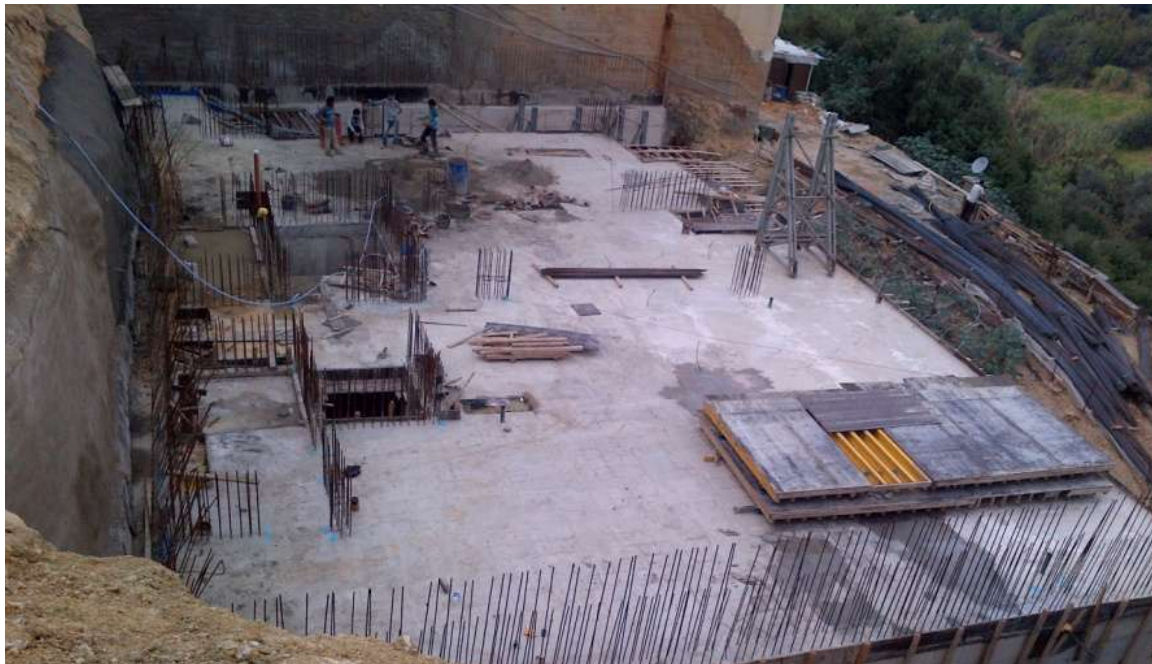
**Figure 3-Level 1 slab**

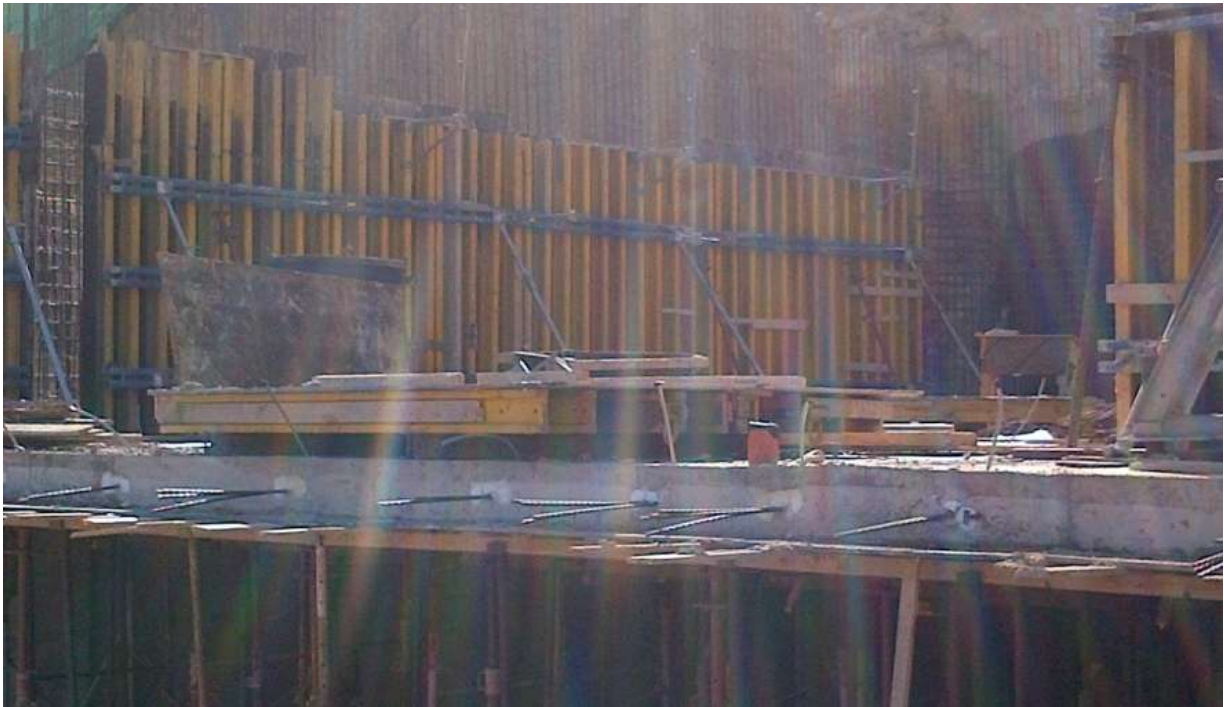
**Figure 4-Formwork for wall level 1**

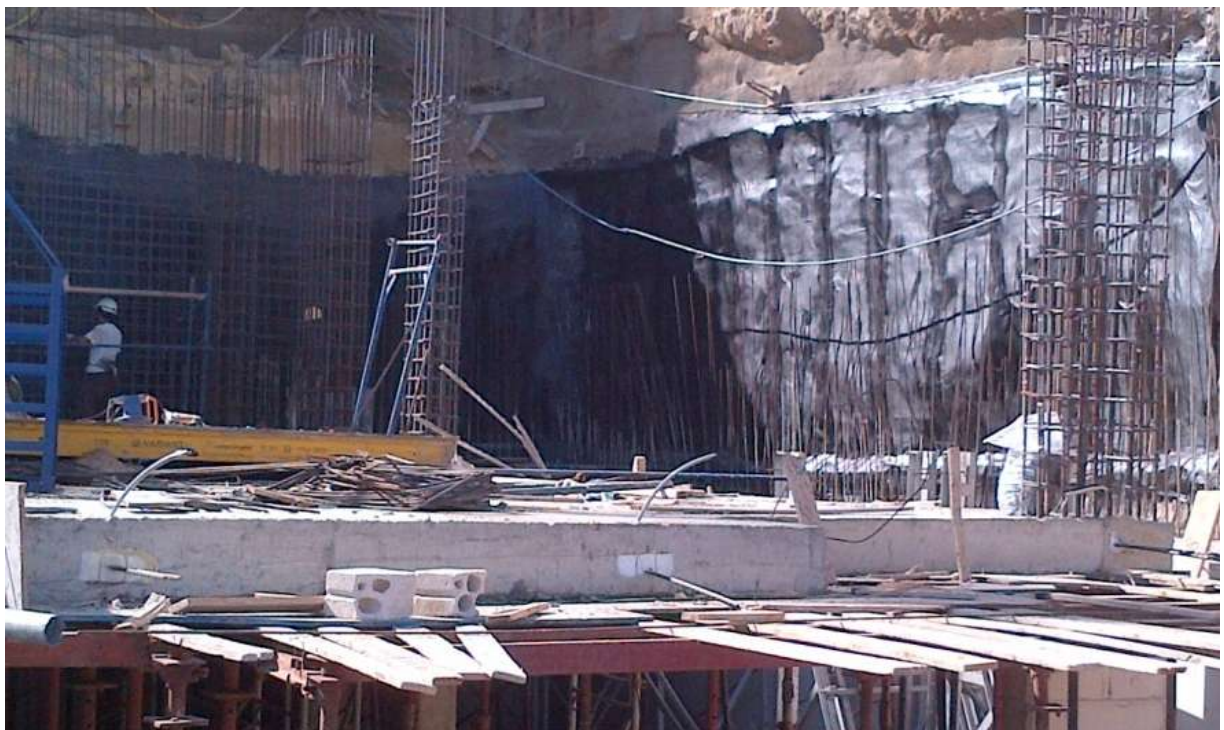
**Figure 5-Waterproofing**

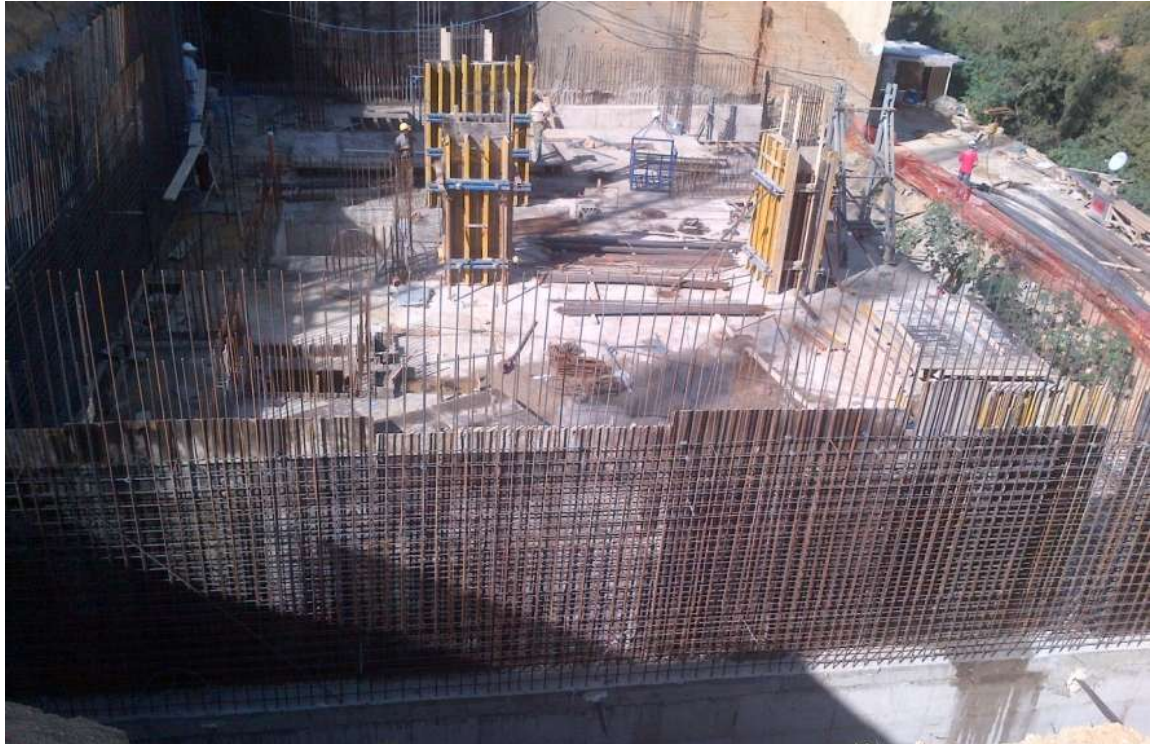
**Figure 6-Works on level 1 slab**

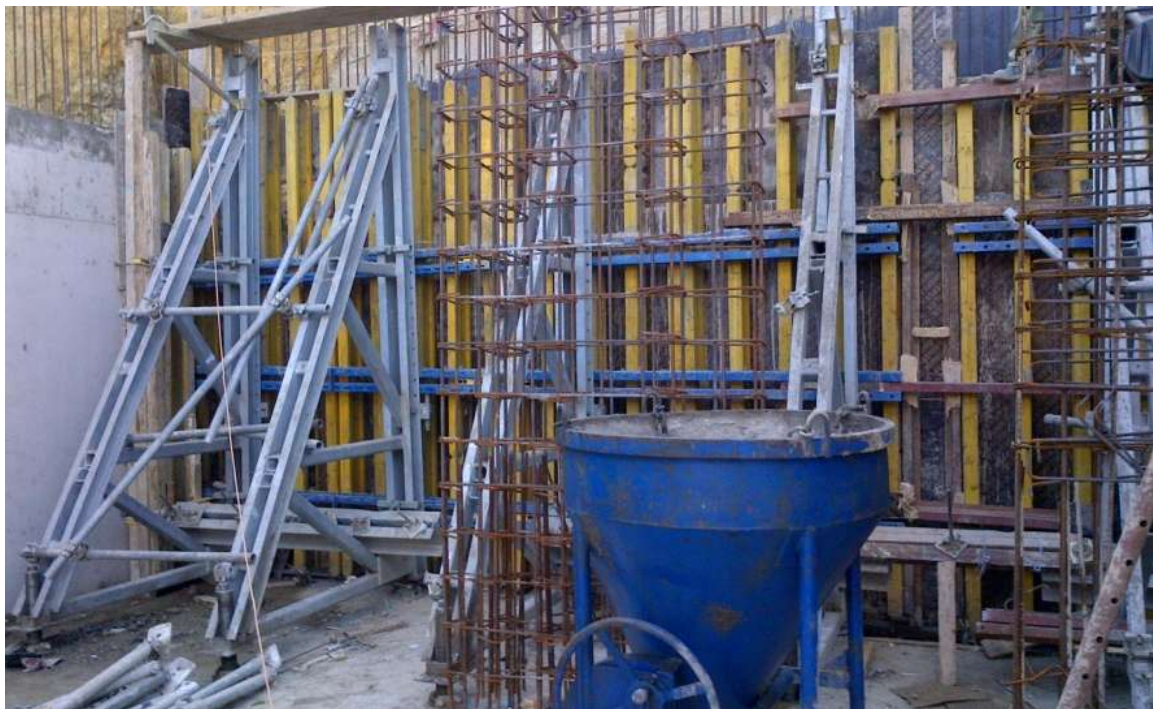
**Figure 7-Formwork for wall level 1**

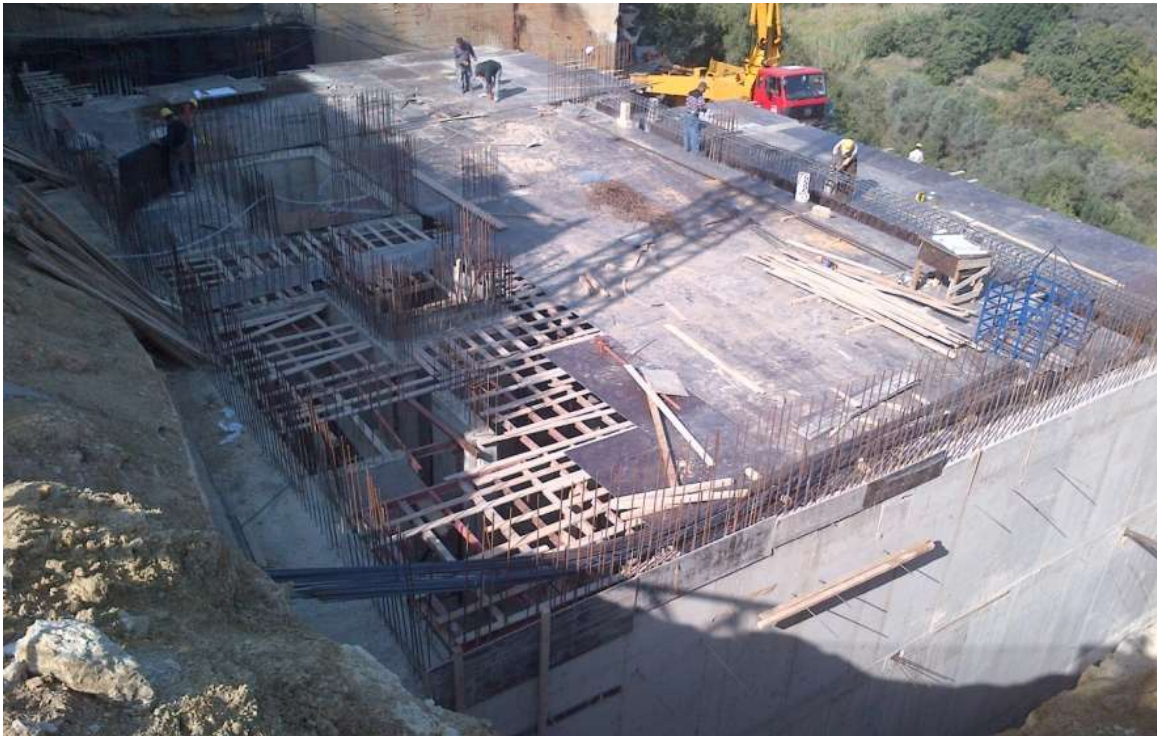
**Figure 8-Formwork for level 2 slab**

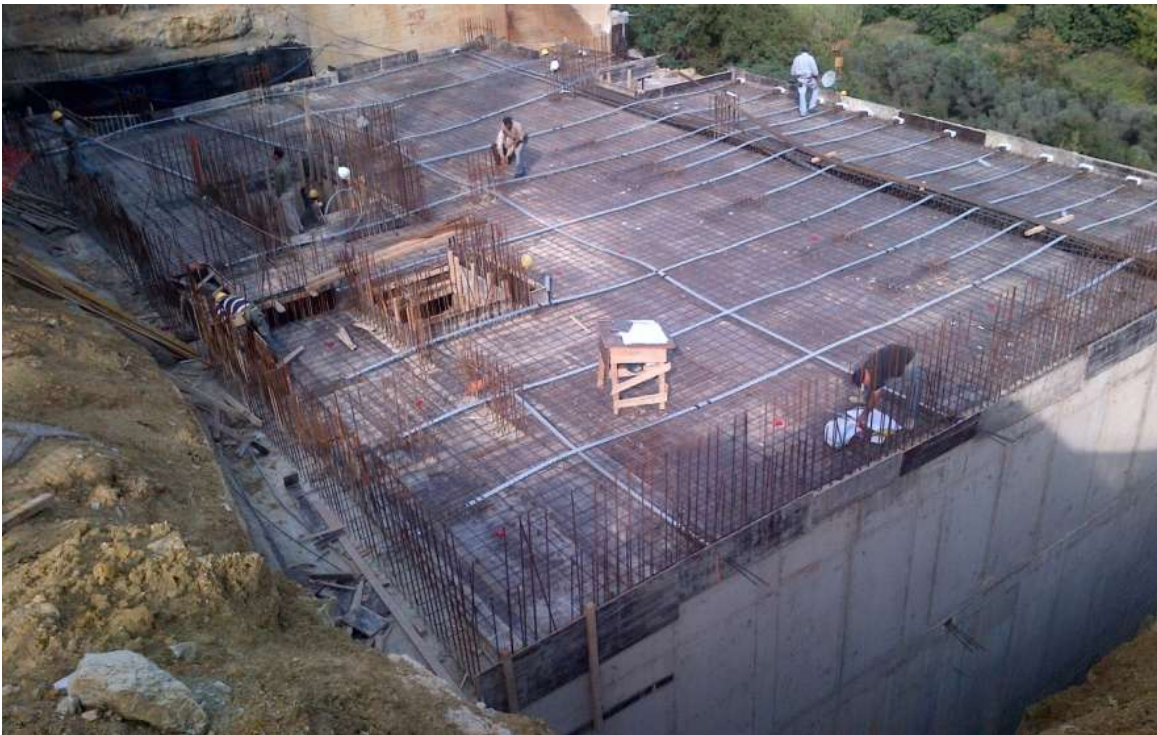
**Figure 9-Reinforcement and PT works for level 2 slab**

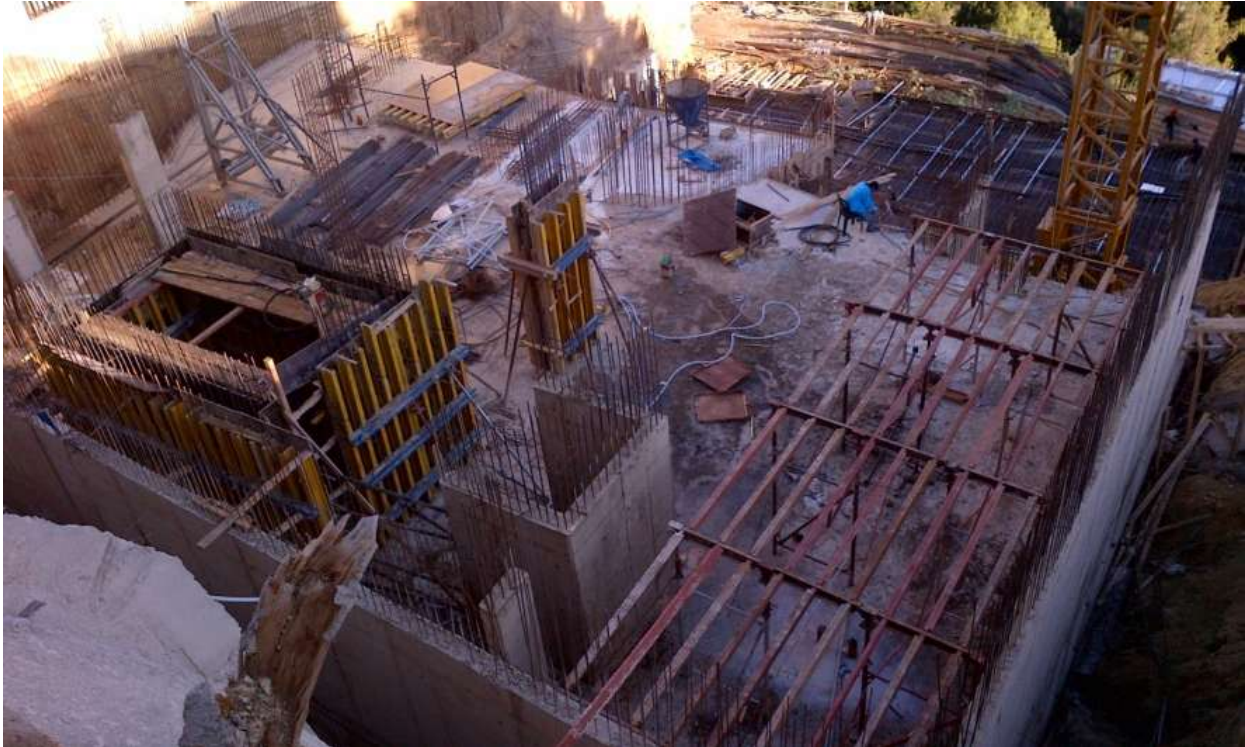
**Figure 10-Work on garden floor slab**

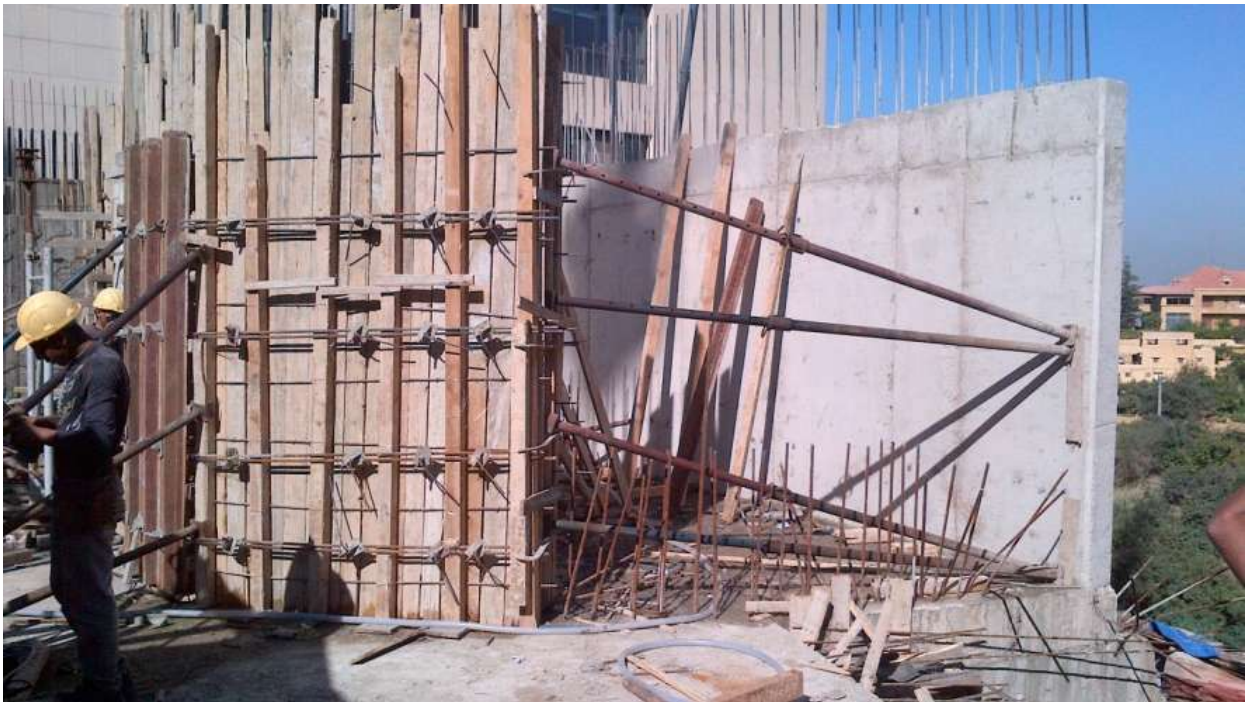
**Figure 11-Formwork for ramp wall Garden Floor**

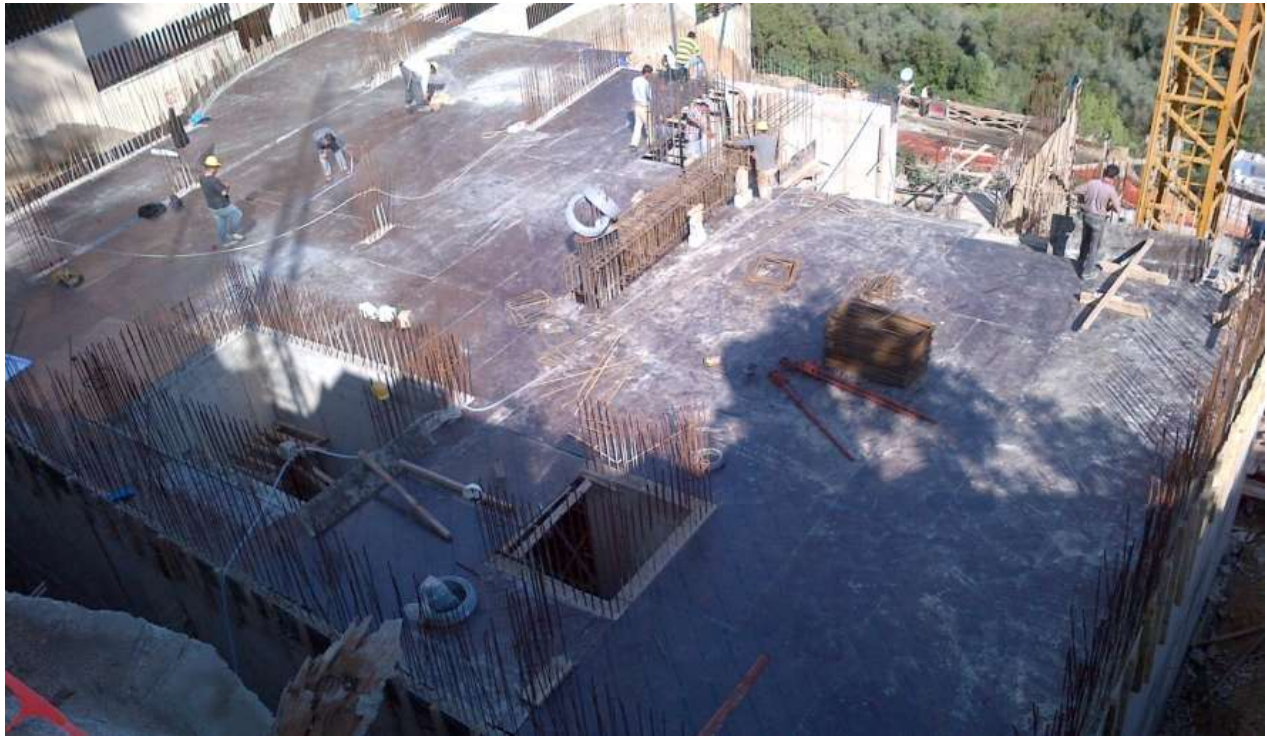
**Figure 12-Formwork for garden floor slab**

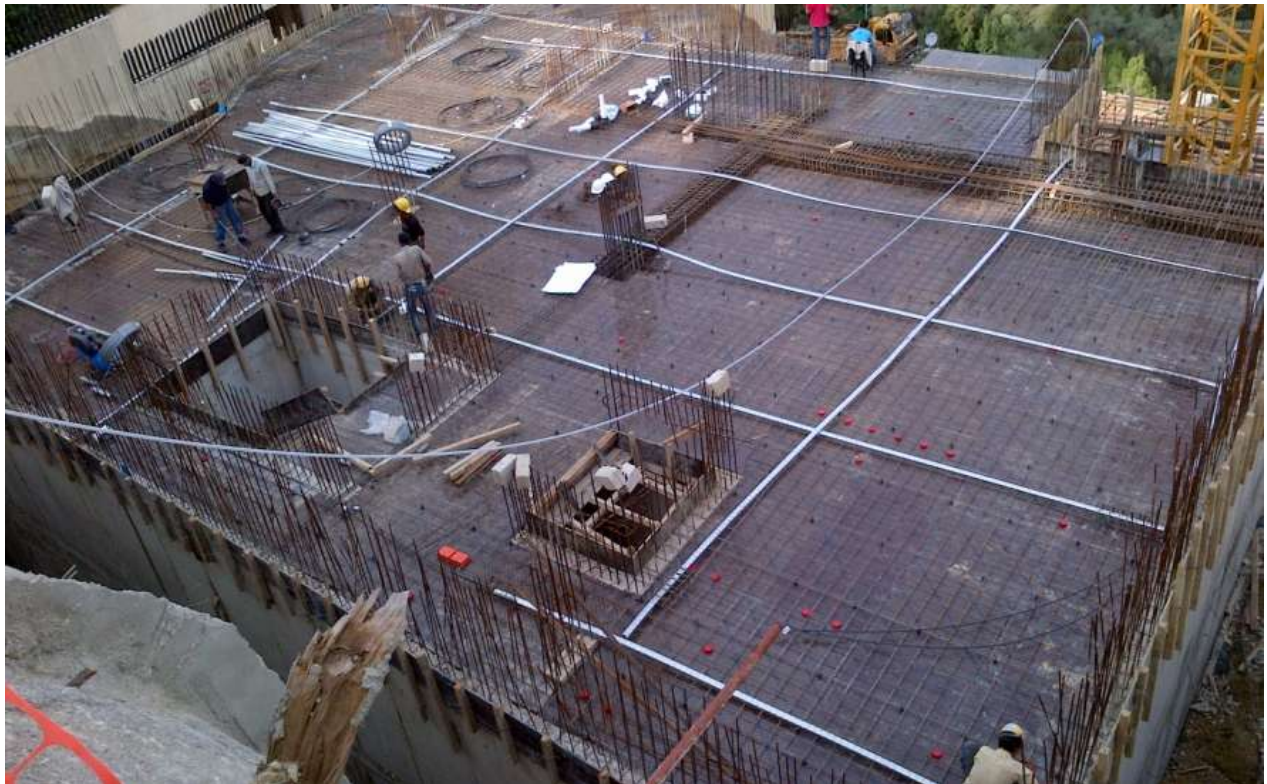
**Figure 13-Reinforcement and PT works for garden floor slab**

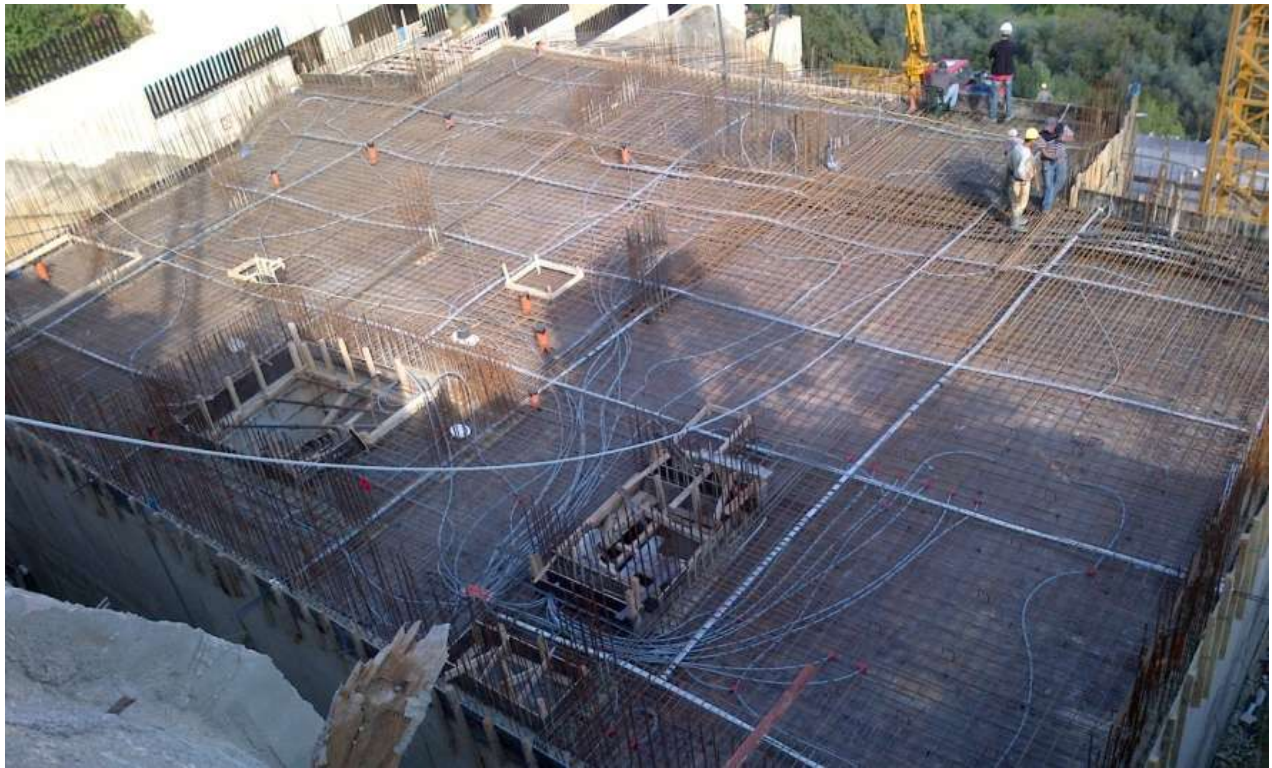
**Figure 14-Reinforcement and PT works for garden floor slab**

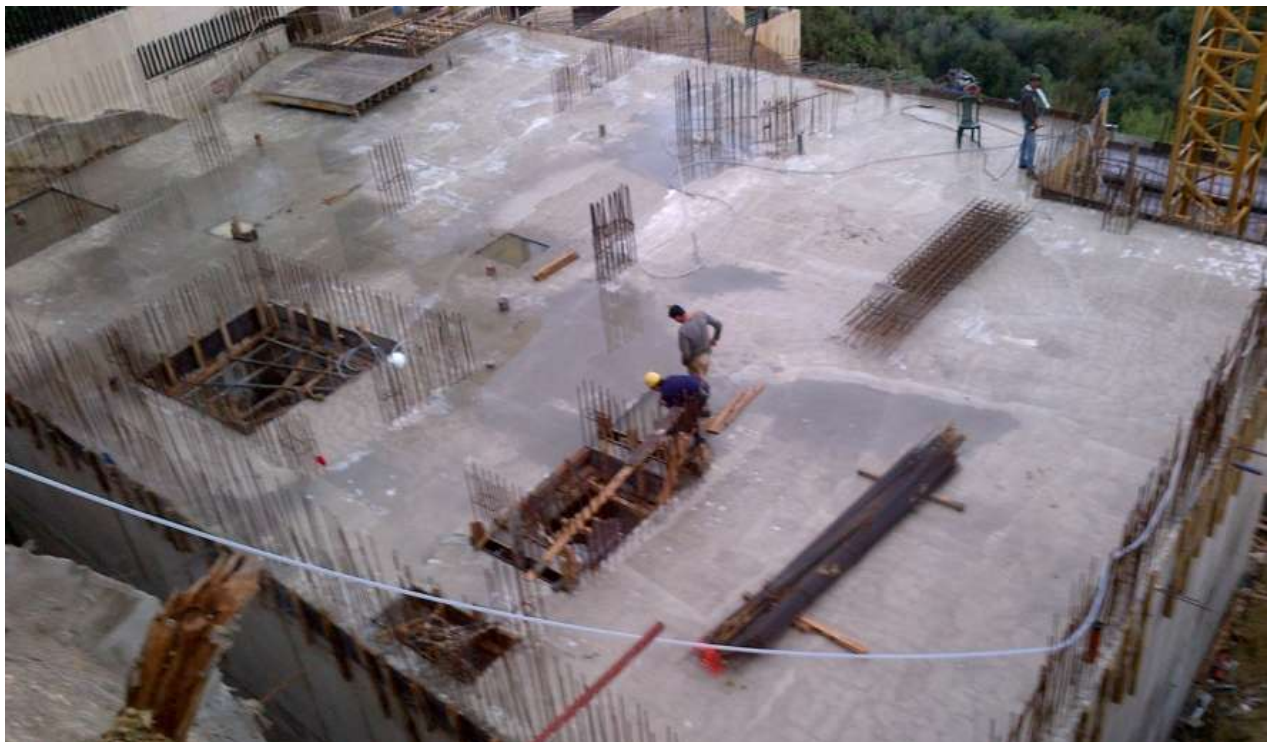
**Figure 15-Garden floor slab**
