January
2013

YARZE 3244

Progress Report

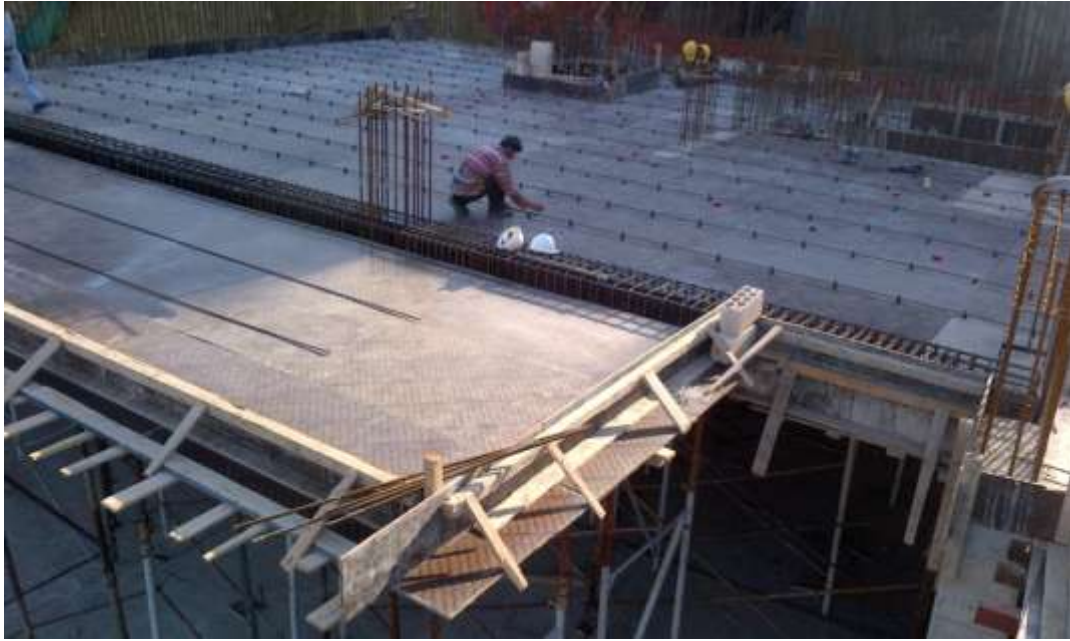
Figure 2-Formwork and reinforcement for level 3 slab

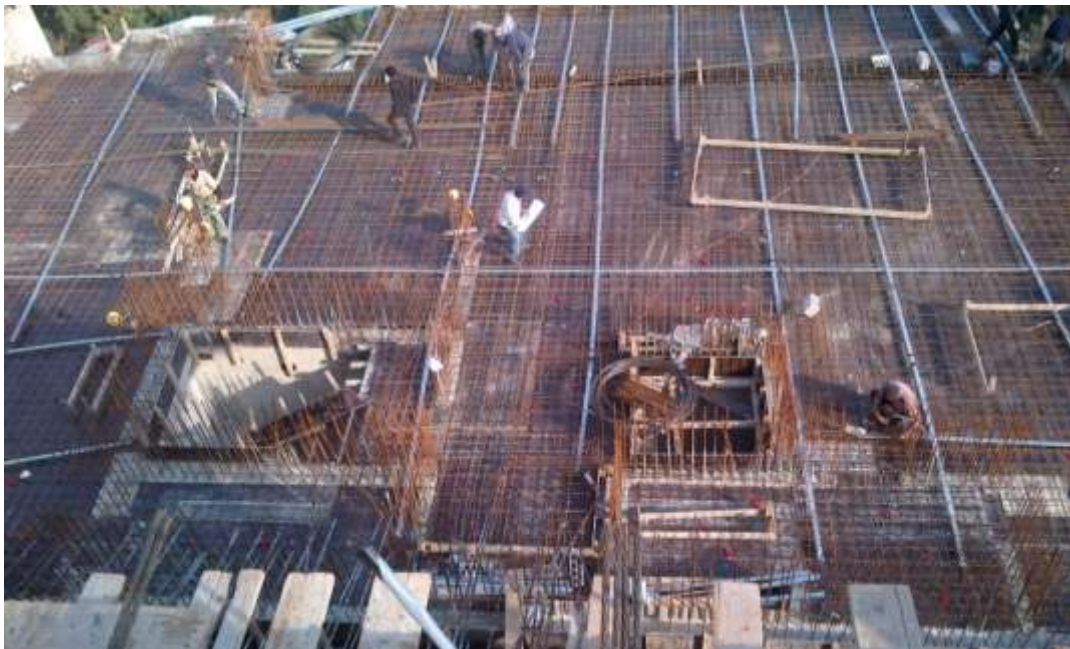
Figure 3-Reinforcement for level 3 slab

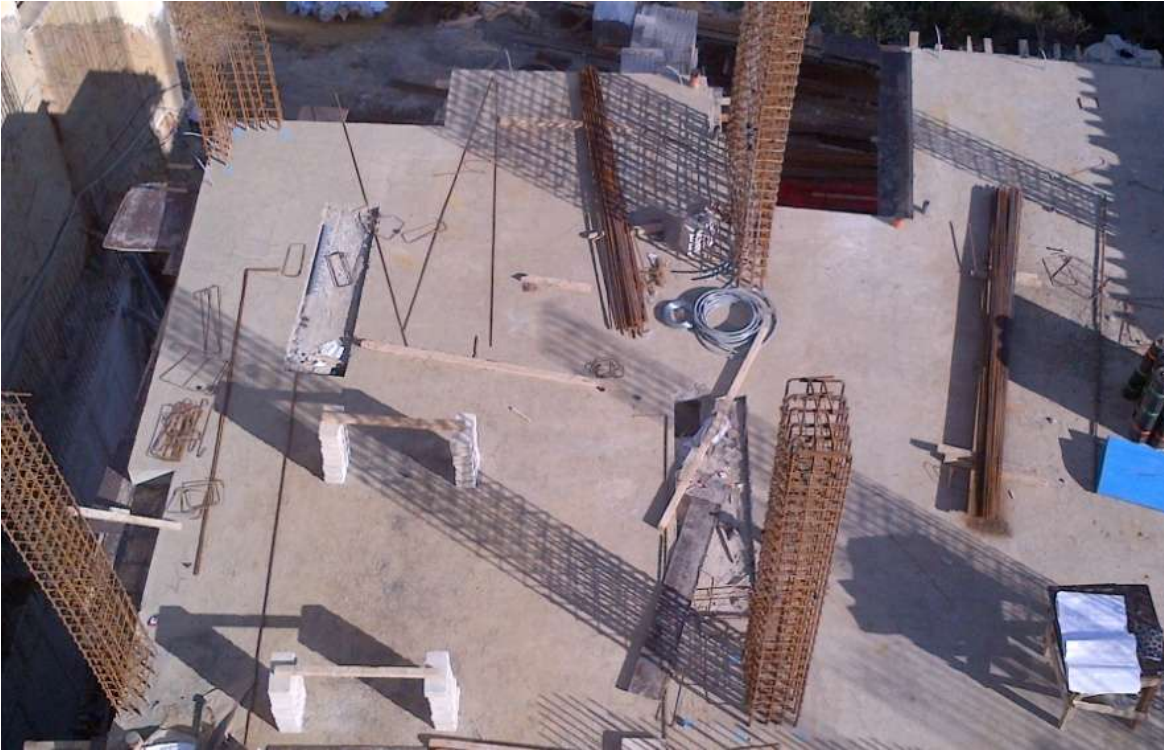
Figure 4-Steel works for columns level 3

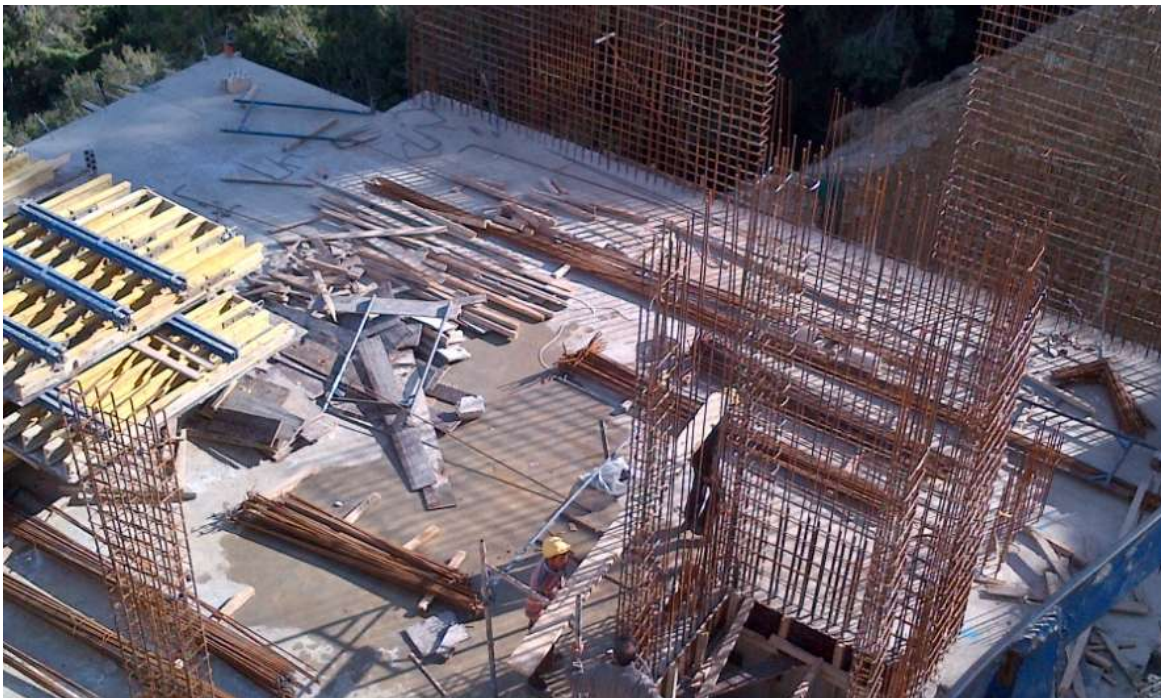
Figure 5-Steel works for core and basement walls level 3

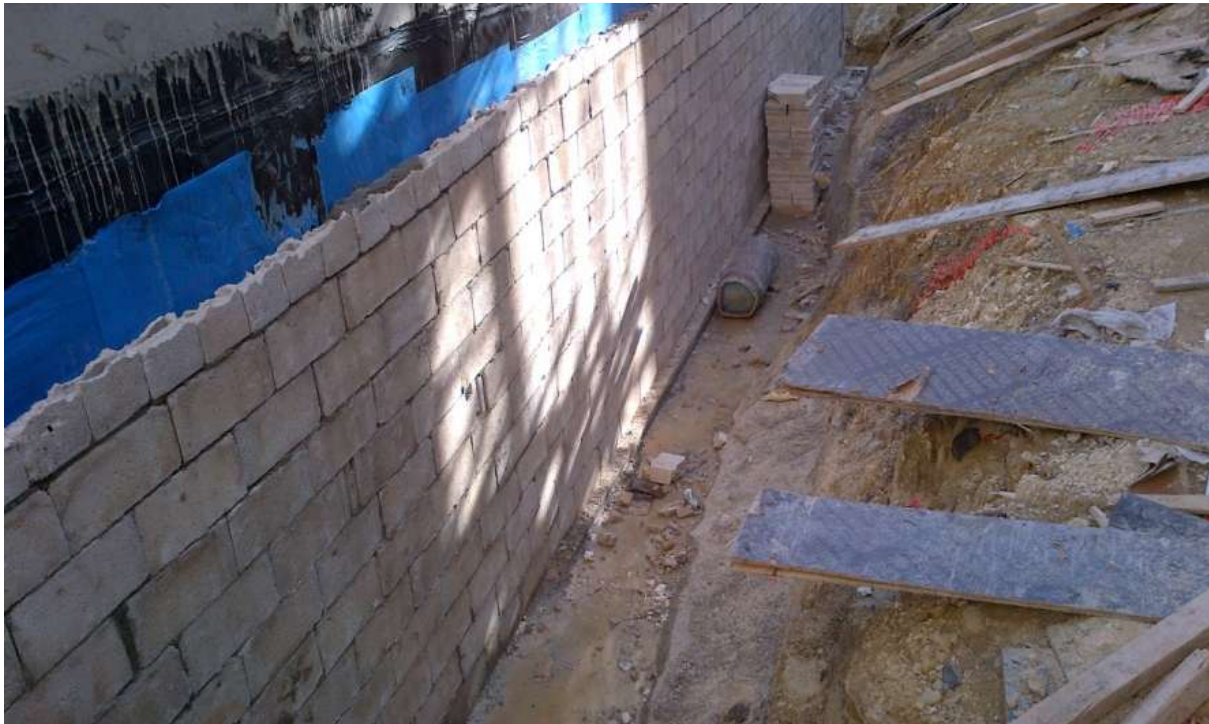
Figure 6-Waterproofing and block installation for basement walls

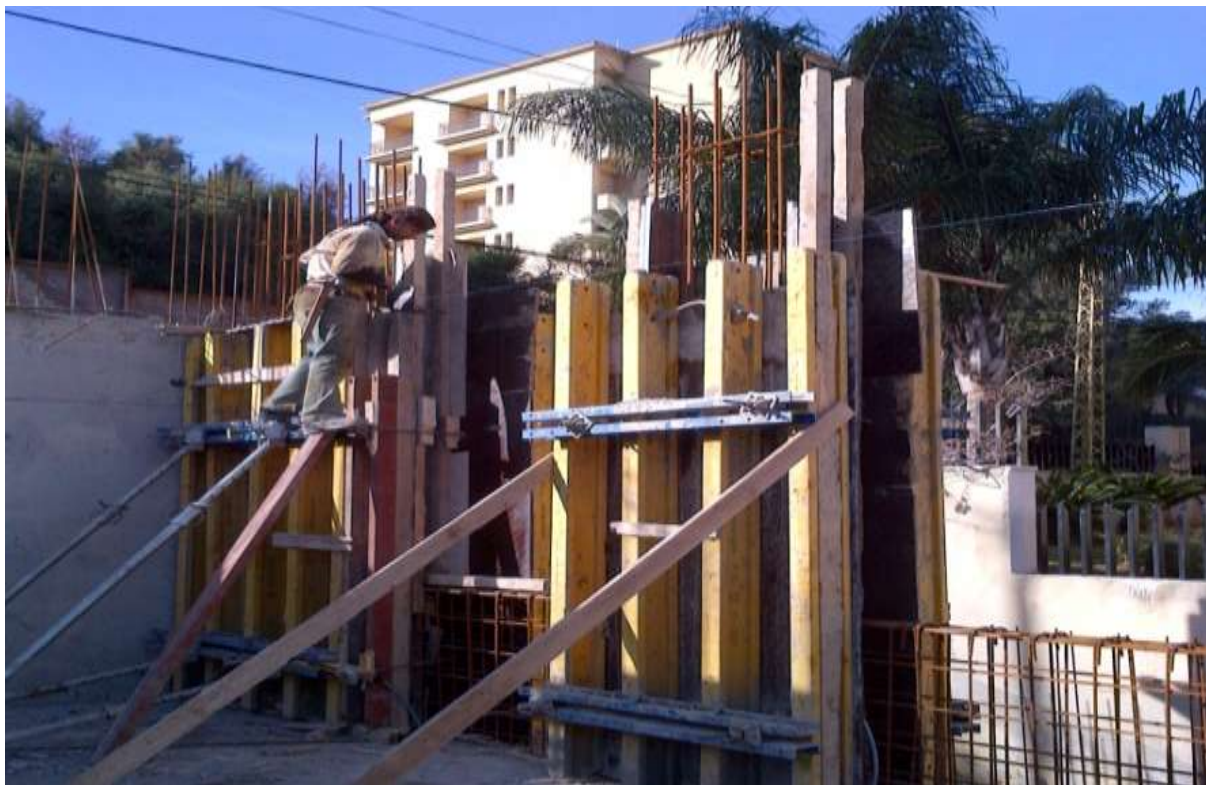
Figure 7-Formwork for columns garden floor

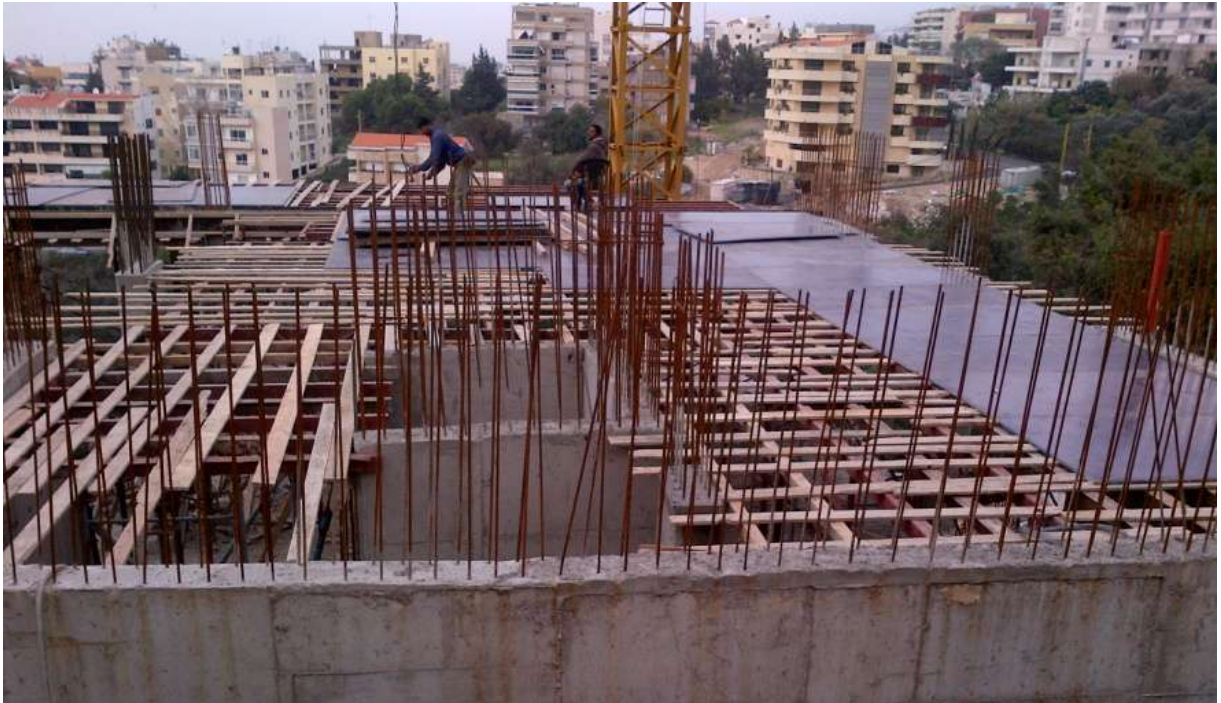
Figure 8-Formwork for slab level 0

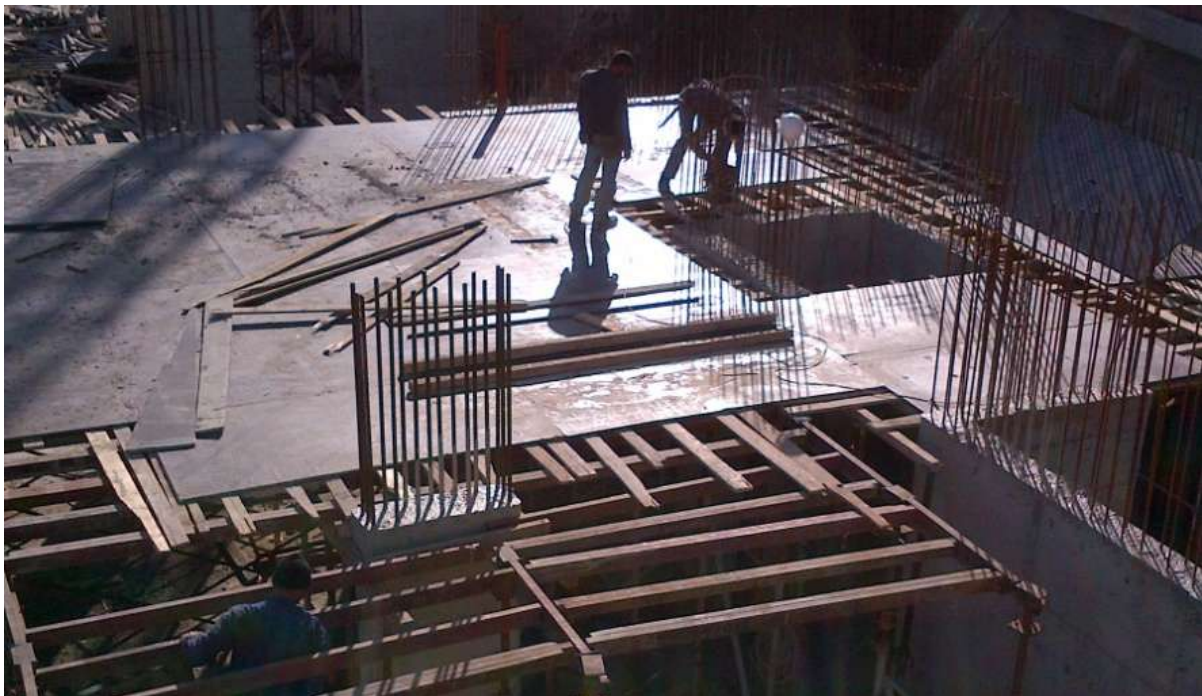
Figure 9-Formwork for slab level 0

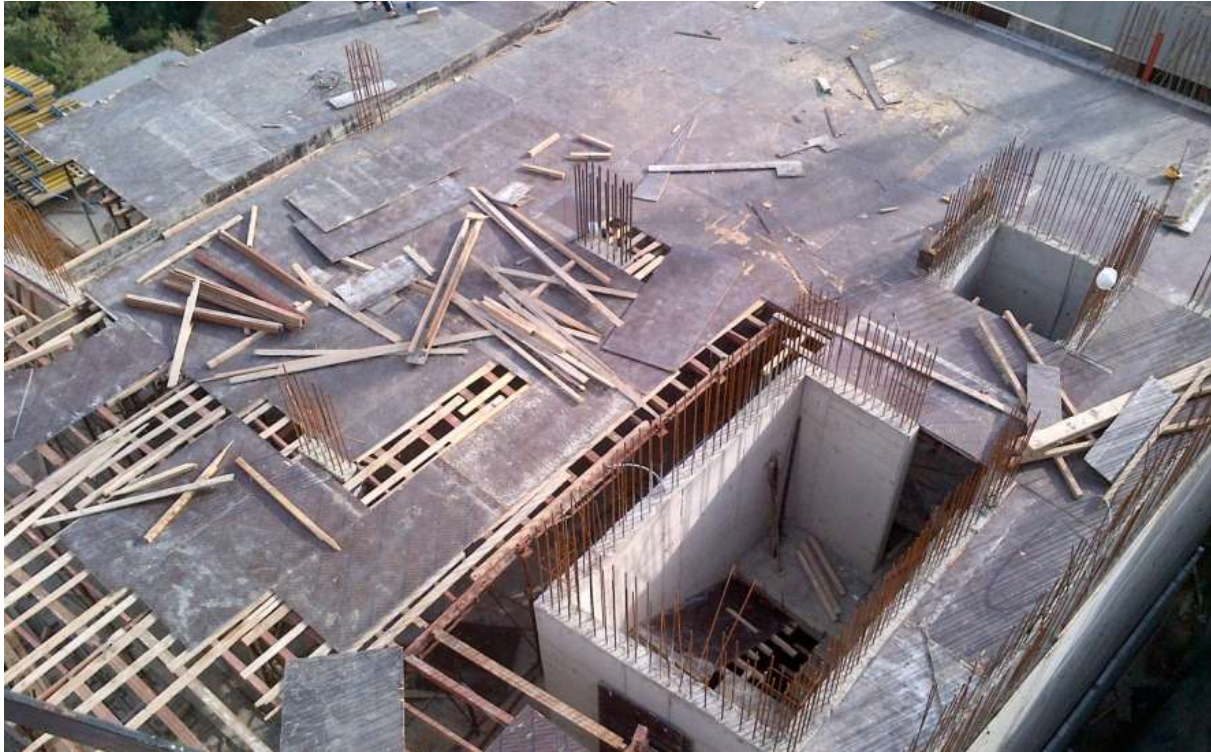
Figure 10-Formwork for slab level 0

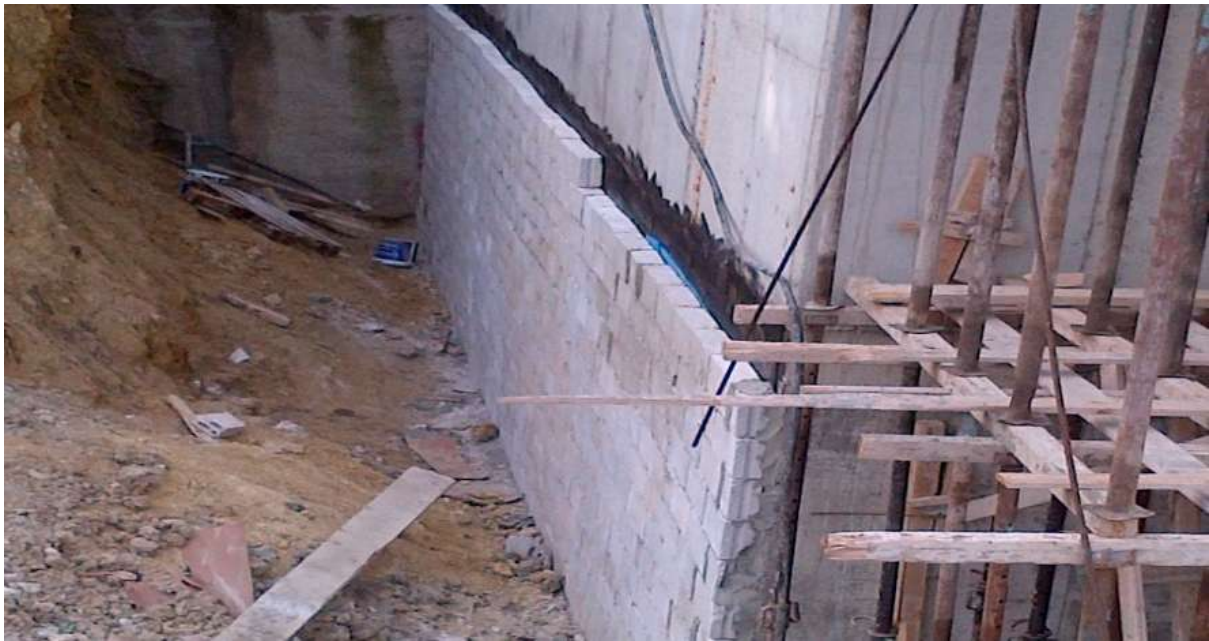
Figure 11-Waterproofing and block installation for basement walls

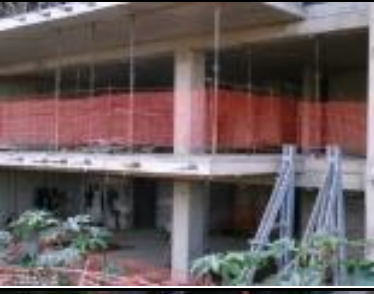
Project Name : Yarzi		Date :25 /01/2013	
Project Manager : Jossef Antonios		Reference : KR/0005/Y	
Health & Safety Inspector : Kassem Raya			
Description/Location	proposed solution	comment	PHOTOS
Balconies are fenced	Edges must be safe and fenced to avoid falling accidents	Done

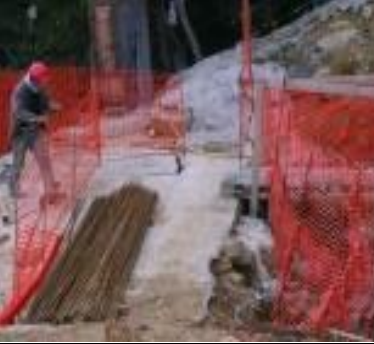
Edges on the site are fenced and precautions done.	Edges should be fenced to avoid falling accidents and precautions taken to prevent collapse.	Done

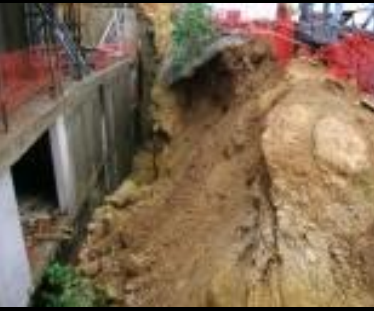
Collapse of the soil due to heavy rain	All persons are prevented to pass by this spot and fence put to prevent accidents	pending

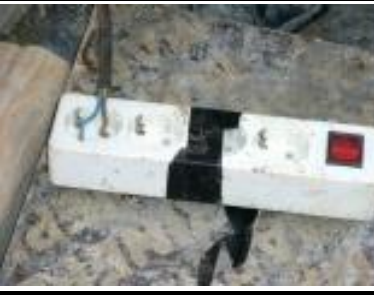
Electrical cables are not covered	Electrical equipments must be used	Done

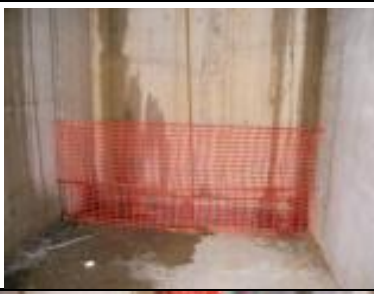
Openings of the lifts in the 2nd floor are closed and fenced	Openings should be fenced and closed to avoid falling accidents	Done

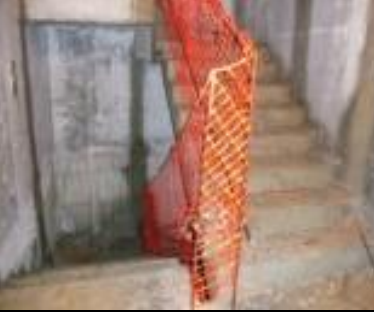
Stairs are fenced	Stairs must be fenced to avoid falling accidents	Done

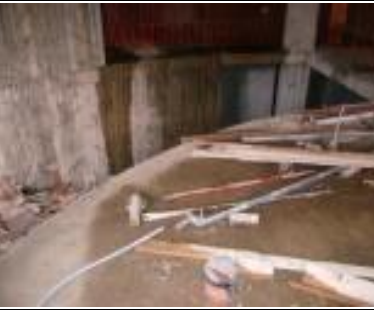
Ramp access not fenced and not clean	Ramp access must be fenced and clean	Done
