September
2012

SPOT -C-

Progress Report

Project Title:	Choueifat Mall	CM
Location:	Choueifat, Lebanon	
Developer:	B.A. Choueifat	BA
Main Contractor:	Dolmen contracting	DC
Shoring subcontractor-1	DST	DST
Shoring subcontractor-2	MGM	MGM
Consultant	DNA	DNA
Technical Control	Socotec	STC
Building Materials Consultant	3PE-3rd Party Engineering	3PE

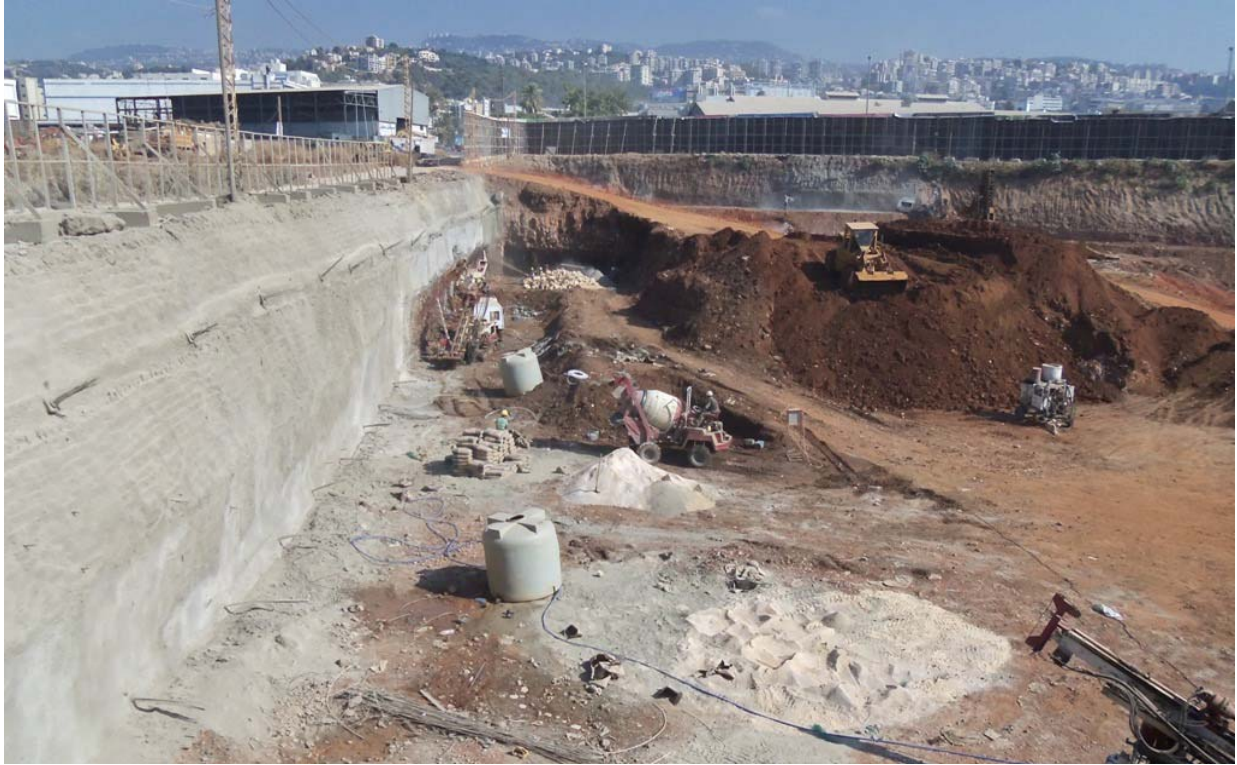
Description/Location	proposed solution	comment	PHOTOS
<p>Laborer on site not wearing helmet,gloves and safety boot.</p>	<p>Usage of PPE.</p>	<p>Pending due to DST not provided PPE for laborers yet.</p>

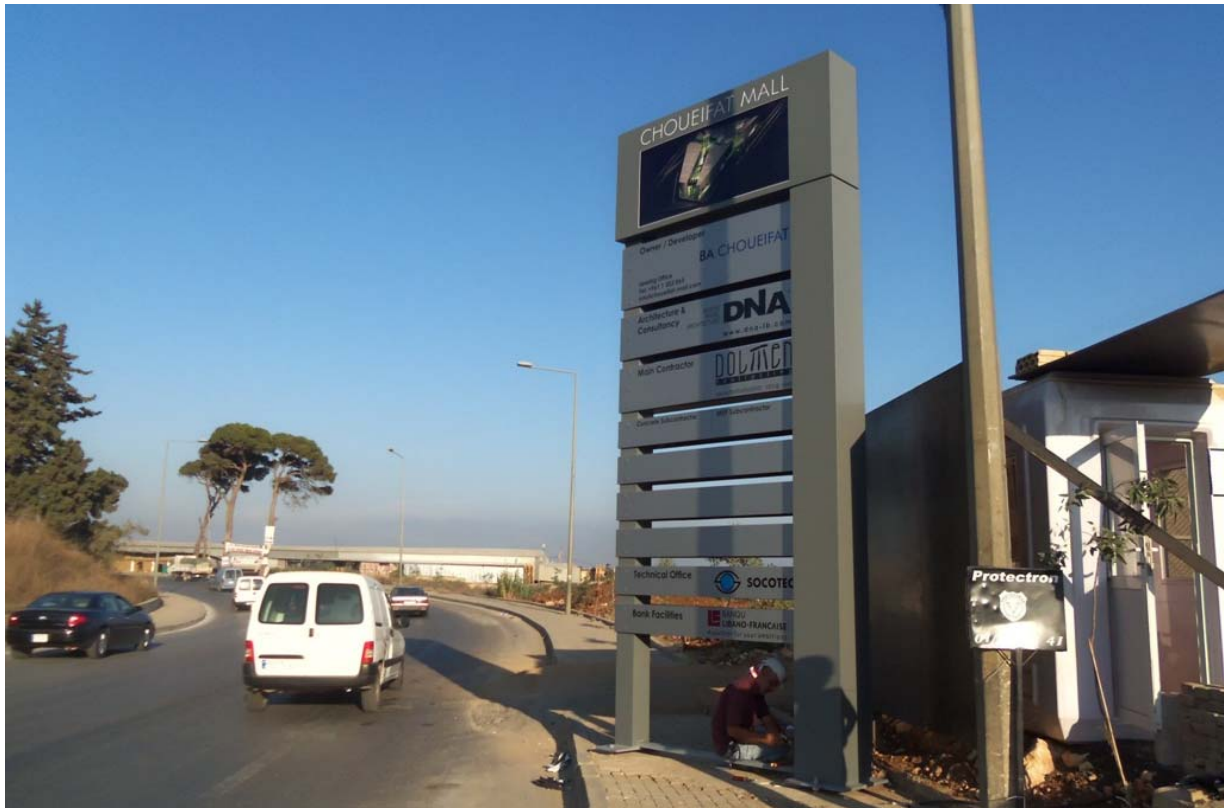
<p>Not wearing the goggles.</p>	<p>Usage of goggles.</p>	<p>Goggles used.</p>
